**Building Information - Yellow Springs Exempted Village (45674) - Yellow Springs High School/McKinney Middle School**

Program Type	Expedited Local Partnership Program (ELPP)
Setting	Small City
Assessment Name	Yellow Springs High (42416) FINAL
Assessment Date (on-site; non-EEA)	2017-03-29
Kitchen Type	Full Kitchen
Cost Set:	2017
Building Name	Yellow Springs High School/McKinney Middle School
Building IRN	42416
Building Address	420 East Enon Road
Building City	Yellow Springs
Building Zipcode	45387
Building Phone	(937) 767-7224
Acreage	37.82
Current Grades:	7-12
Teaching Stations	22
Number of Floors	3
Student Capacity	412
Current Enrollment	383
Enrollment Date	2017-03-29
Enrollment Date is the date in which the current enrollment was taken.	
Number of Classrooms	1
Historical Register	<b>NO</b>
Building's Principal	Mr. Tim Krier
Building Type	Middle/High

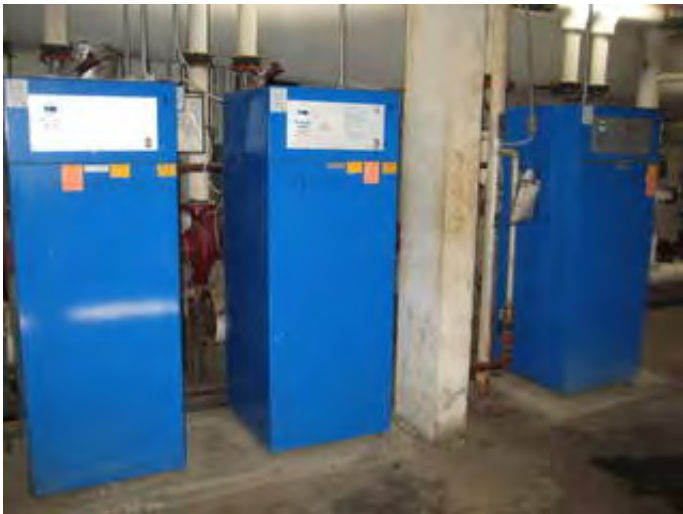
The existing system for the overall facility is a natural gas fired heated water boiler type system, installed in 1963, with some recent upgrades, and is in fair condition. The existing systems for the 1988 and 2002 Additions are natural gas fired packaged roof top unit type system, installed in 1988 and 2002, and are in fair condition. 2-pipe vs. 4-pipe designations are not applicable in this facility, as no central air conditioning is provided. The (3) heated water boilers, manufactured by Patterson-Kelley Co., are assumed to be installed in 1998 and are in fair condition. Heating water is distributed to terminal units consisting of unit ventilators, cabinet heaters, unit heaters, fin tubes, air handlers, and multiple roof top units. The 1988 Addition is equipped with (6) ducted packaged roof top units (with DX cooling and natural gas/hot water heat), manufactured by Trane, were installed in 1988, and are in fair condition. Heated air is distributed to terminal units consisting of multiple VAV boxes. The 2002 Addition is equipped with (5) ducted packaged roof top units (with DX cooling and natural gas/hot water heat), manufactured by York, were installed in 2002, and are in fair condition. Heated air is distributed to terminal units consisting of multiple VAV boxes. All terminal equipment is original to each addition and is in fair condition. The system does not comply with the 15 CFM per person fresh air requirements of the Ohio Building Code mechanical code and Ohio School Design Manual. The pneumatic, digital, and DDC type system temperature controls are original to each addition with incremental upgrades and are in fair condition. The system does not feature individual temperature controls in all spaces required by the OSDM. The overall system does not feature any central energy recovery systems. The 1963 Original Construction is equipped with widespread louvered interior doors to facilitate Corridor utilization as return air plenums. The remainder of the overall facility is not equipped with louvered interior doors to facilitate Corridor utilization as return air plenums. The existing system is ducted in the 1988 and 2002 Additions and a portion of the 1963 Original Construction, but the ductwork cannot be integrated into a possible future system due to arrangement, air volume, and routing of existing ductwork. The existing system in the remainder of the overall facility is not ducted, and floor to structural deck heights will not accommodate the installation of properly sized ductwork for a future Ohio School Design Manual approved system. The overall heating system is evaluated as not being in safe and efficient working order, and long term life expectancy of the existing system is not anticipated. The structure is not equipped with central air conditioning. The site does not contain underground fuel tanks.

Natural Gas Fired Heated Water Boilers

Provide new overall heating, ventilating, and air conditioning system to achieve compliance with Ohio Building Code and Ohio School Design Manual standards. Replace existing ductwork in the 1988 and 2002 Additions and a portion of the 1963 Original Construction to facilitate efficient exchange of conditioned air. Convert to ducted system the remainder of the overall facility to facilitate efficient exchange of conditioned air. Provide architectural soffits to accommodate the installation of ductwork.

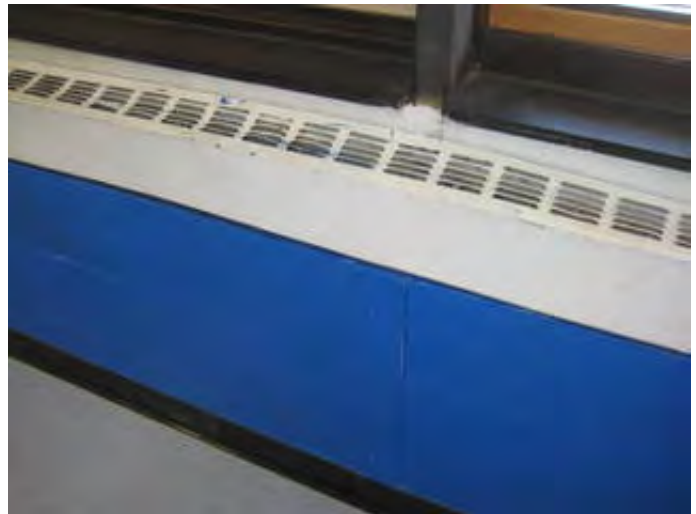
Heating Water Fin Tube Heater

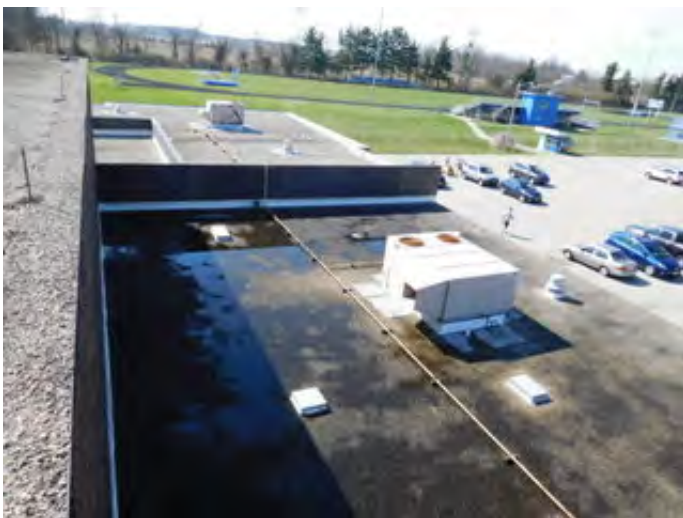
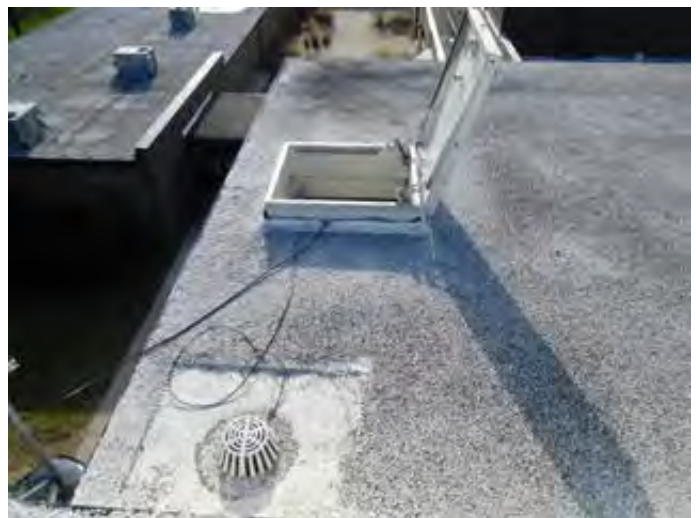
**Description:** The roof over the Original Construction is a built-up system with gravel ballast that was installed in 1994, and is in fair condition; portions of the Original Construction were replaced with a built-up system in 2009, and is in fair condition. The roof over the 1988 Addition is a modified bitumen system that was installed in 2003, and is in fair condition. The roof over the 1999 Addition is a built-up system with gravel ballast that was installed in 1999, and is in fair condition. The roof over the 2002 Addition is a built-up system with gravel ballast that was installed in 2004, and is in good to fair condition. There are no District reports of current leaking. No signs of past leaking were observed during the physical assessment. Access to portions of the roof was gained by access hatches that are in poor condition. Fall safety protection cages are not required. There were observations of standing water on the roof. Metal cap flashings and stone copings are in fair to poor condition. Roof storm drainage is addressed through a system of gutters and downspouts and roof drains, which are properly located, and in fair condition. The roof is not equipped with overflow roof drains in all additions though they will be required in areas of roof replacement. No problems requiring attention were encountered with any roof penetrations. There are not any covered walkways attached to this structure.

**Rating:** 3 Needs Replacement

Typical Roof

**Recommendations:** The roof over the overall facility requires replacement to meet Ohio School Design Manual guidelines due to age of system and projected lifecycle. The flashing and coping on the overall facility require replacement due to condition. Due to existing conditions roof drains require replacement on the overall facility with the exception of the 2002 Addition. Due to existing conditions gutters and downspouts and roof drains require replacement. Provide funding for overflow roof drains and piping for the Original construction and the 1999 Addition. Due to age and condition provide for the replacement of two roof access ladders and hatches. Provide one new roof access ladder and hatch to provide access to all roof areas. Provide funding for guardrails to be added at the location of the two existing roof access hatches due to life safety.

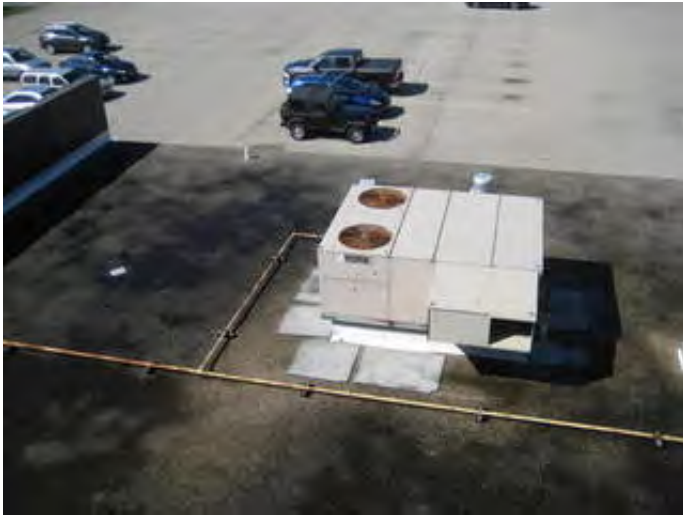
**Description:** The overall facility is not equipped with a central air conditioning system. Window units are located in several Classroom locations in the overall facility. An isolated room system consisting of an electric fired LG ducted split VRF type system (with the condensing units pad mounted and located on the exterior) is provided in the 3-story portion of the 1963 Original Construction. Isolated room systems consisting of multiple ducted packaged air cooled Trane and York roof top units (with DX cooling and natural gas/hot water heating) are provided in the Administrative Offices of the 1963 Original Construction, as well as throughout the 1998 and 2002 Additions. The ventilation system in the overall facility consists of unit ventilators, air handlers, and roof top units, original to each addition and in fair condition, providing fresh air to Classrooms, and air handlers and roof top units, original to each addition and in fair condition, providing fresh air to other miscellaneous spaces such as Gymnasium, Student Dining, and Media Center. Relief air venting is provided by louvered interior doors, central relief fans, air handlers, and roof top units. The ventilation system does not meet the Ohio Building Code 15 CFM per occupant fresh air requirement. The overall system is not compliant with Ohio Building Code and Ohio School Design Manual requirements. Dust collection systems are not required. The Art program is equipped with two (2) kilns, and existing kiln ventilation is inadequate, and in fair condition. General building exhaust systems for Restrooms, Storage Rooms, Art Rooms, and Custodial Closets are inadequately placed, and in fair condition.

**Rating:** 2 Needs Repair

Roof Top Unit

**Recommendations:** Provide an air conditioning system to meet with Ohio Building Code and Ohio School Design Manual requirements. Replace general building exhaust systems located in Restrooms, Storage Rooms, and Custodial Closets. Pricing included in Item A. Replace the existing Art Program's kiln ventilation system due to age, condition, and lack of OSDM compliance.

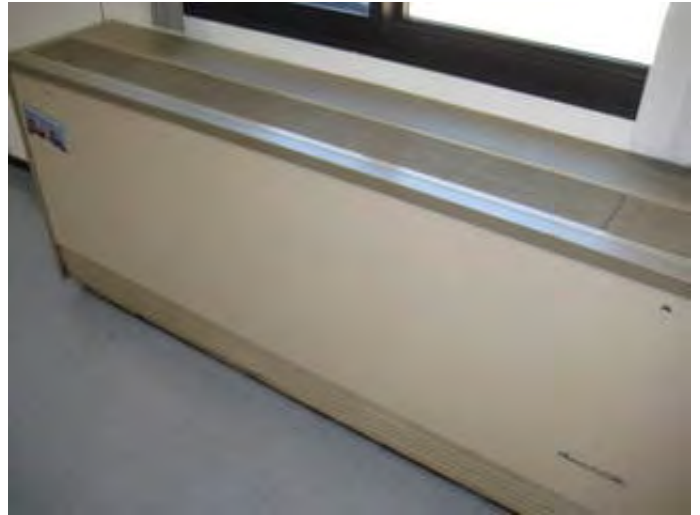
Unit Ventilator

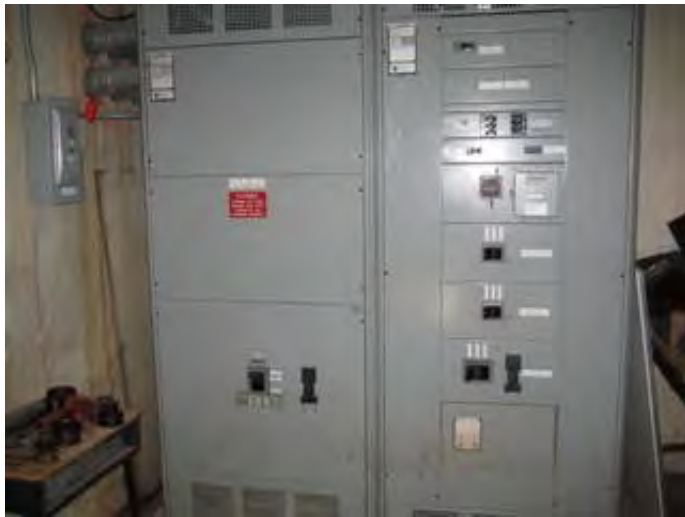
**Description:** The electrical system provided to the 2002 Addition is a 120/208 volts, 1,600 amp, 3 phase and 4 wire system installed in 2002, and is in good to fair condition. The systems in the 1963 Original Condition and 1988 and 1999 Additions are an extension of that found in the 2002 Addition. Power is provided to the school by a single utility owned, pad-mounted transformer located outside the Mechanical Room, and in fair condition. The panel systems, original to each addition, are in fair condition, and for the most part cannot be expanded to add additional capacity. The Classrooms are not equipped with adequate electrical outlets. The typical Classroom contains (6) general purpose outlets, (0) dedicated outlets for each Classroom computer, and (1) dedicated outlet for each Classroom television/ceiling mounted projector. Some Classrooms are equipped with as many as (7) general purpose outlets, while others are equipped with as few as (4) general purpose outlets. There are not any spaces that have no electrical outlets. The Corridors are equipped with adequate electrical outlets for servicing. Adequate GFI protected exterior outlets are not provided around the perimeter of the building. The facility is not equipped with an emergency generator. Adequate lightning protection safeguards are not provided. Stage lighting power system including control panel, breakers, and dimmers is inadequately provided, in fair condition and does not fully meet OSDM requirements. The overall electrical system does not fully meet Ohio School Design Manual requirements in supporting the current needs of the school, and will be inadequate to meet the facility's future needs.

**Rating:** 3 Needs Replacement

Main Electrical Distribution Panel

**Recommendations:** The entire electrical system requires replacement to meet Ohio School Design Manual guidelines for overall capacity due to age and condition, lack of OSDM-required features, and to accommodate the addition of an air conditioning system. Provide an emergency generator, with funding included in the electrical system replacement. Provide adequate lightning protection safeguards in the overall facility, including associated grounding system, with funding included in the electrical system replacement.

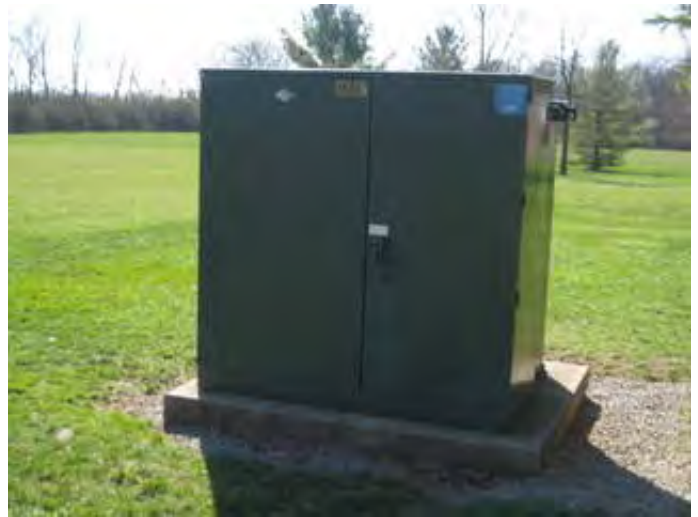
Pad Mounted Transformer

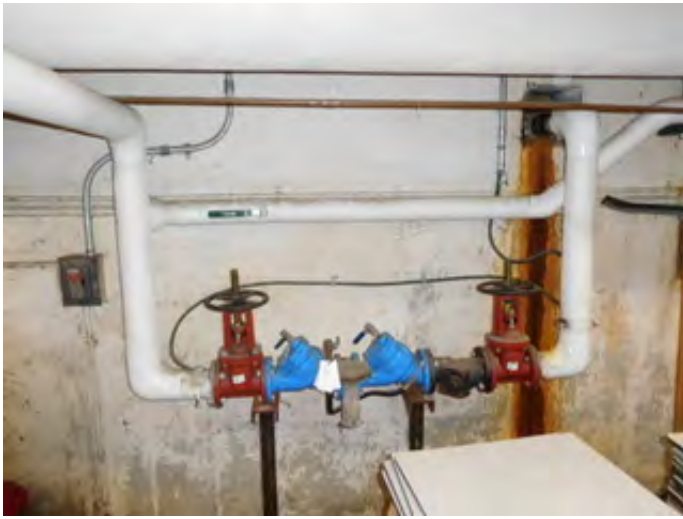
Description:	<p>The service entrance is equipped with a reduced pressure back flow preventer in good to fair condition. A water treatment system is not provided, though none is needed. The domestic water supply piping in the overall facility is copper and galvanized, is original to each addition, and is in fair condition. The waste piping in the overall facility is cast iron, with some galvanized, is original to each addition, and is in good to fair condition. The facility is equipped with a 40 gallon electric water heater in good to fair condition, and a 91 gallon gas water heater in good condition, with 1 separate 250 gallon storage tank in poor condition. The school contains 3 Large Group Restrooms for boys, 3 Large Group Restrooms for girls, 1 Locker Room Restroom for boys, 1 Locker Room Restroom for girls, 1 Restroom associated with specialty Classrooms, and 2 Restrooms for staff. Boys' Large Group Restrooms contain 3 ADA and 3 non-ADA wall and floor mounted flush valve and tank type toilets, 4 ADA and 5 non-ADA wall mounted flush valve urinals, as well as 5 ADA and 2 non-ADA countertop and wall mounted lavatories. Girls' Large Group Restrooms contain 3 ADA and 8 non-ADA wall and floor mounted tank type and flush valve toilets, as well as 5 ADA and 2 non-ADA countertop and wall mounted lavatories. Boys' Locker Room Restrooms contain 0 ADA and 1 non-ADA wall mounted flush valve toilets, 0 ADA and 1 non-ADA wall mounted flush valve urinals, 0 ADA and 1 non-ADA countertop lavatories, as well as 0 ADA and 9 non-ADA showers. Girls' Locker Room Restrooms contain 0 ADA and 2 non-ADA wall mounted flush valve toilets, as well as 0 ADA and 2 non-ADA countertop lavatories, as well as 0 ADA and 8 non-ADA showers. Staff Restrooms contain 0 ADA and 3 non-ADA wall and floor mounted tank type and flush valve toilets, 0 ADA and 0 non-ADA urinals, as well as 0 ADA and 3 non-ADA wall mounted lavatories. Condition of fixtures is good to fair. The facility is equipped with 0 ADA and 0 non-ADA drinking fountains, as well as 2 ADA and 7 non-ADA electric water coolers, in good to fair condition. High School Special Education Classrooms are equipped with 0 ADA and 0 non-ADA sink mounted type drinking fountains. Special Education Classroom is equipped with the required Restroom facilities, and fixtures are in fair condition. Kitchen is not equipped with the required Restroom. Heath Clinic is not equipped with the required Restroom. Due to existing grade configuration, Kindergarten / Pre-K Classroom Restroom considerations are not relevant. Kitchen fixtures consist of 2 single compartment sink and 1 triple compartment sink, which are in fair condition. The Kitchen is not equipped with a grease interceptor. The Kitchen is provided the required 140 degree hot water supply. The school meets the OBC requirements for fixtures. Relative to LEED requirements, the school is not equipped with low flow type fixtures. Per OBC and OSDM requirements this facility should be equipped with 8 toilets, 2 urinals, 10 lavatories, 1 Classroom sink mounted drinking fountains, and 5 electric water coolers. Observations revealed that the school is currently equipped with 28 toilets, 10 urinals, 25 lavatories, 0 Classroom sink mounted drinking fountains, and 9 electric water coolers. ADA requirements are not met for fixtures and drinking fountains see Item O. Custodial Closets are properly located and are adequately provided with required service sinks or floor drain sinks, which are in fair condition. Science Classrooms / Project Laboratories / Career Tech Laboratories are equipped with required utility sink, gas / compressed air connections, and safety shower / eyewash in good to fair condition. Biology and Chemistry Classrooms are not equipped with acid waste systems and neutralization tanks. Adequate exterior wall hydrants are not provided.</p>

Backflow Preventers

Rating:	3 Needs Replacement
Recommendations:	<p>To facilitate the school's compliance with OBC and OSFC fixture requirements, provide 2 new toilets, 2 new lavatories and 1 new lavatory mounted type drinking fountains. Due to age, condition, LEED, and OSFC requirements, provide 22 new toilets, 21 new lavatories, 8 new urinals and 4 new electric water coolers. Replace water supply and sanitary waste piping in the 1963 Original Construction and 1988 Addition. Due to age replace the electric hot water heater in the 1988 Addition. Due to age and condition, replace the 250 gallon hot water storage tank. Due to age and condition replace all showers in the Original Construction. See Item O for replacement of fixtures related to ADA requirements. Provide the Science Classrooms with the required gas connections, compressed air connections, and safety shower / eyewash stations. Provide the Biology and Chemistry Classrooms with the required acid waste systems and neutralization tanks. See Item J for replacement of Kitchen fixtures. Replace one and provide three new exterior wall hydrants to meet OSFC requirements. Provide the Kitchen with a grease trap interceptor. Replace existing Custodial Closet sinks due to age and condition.</p>

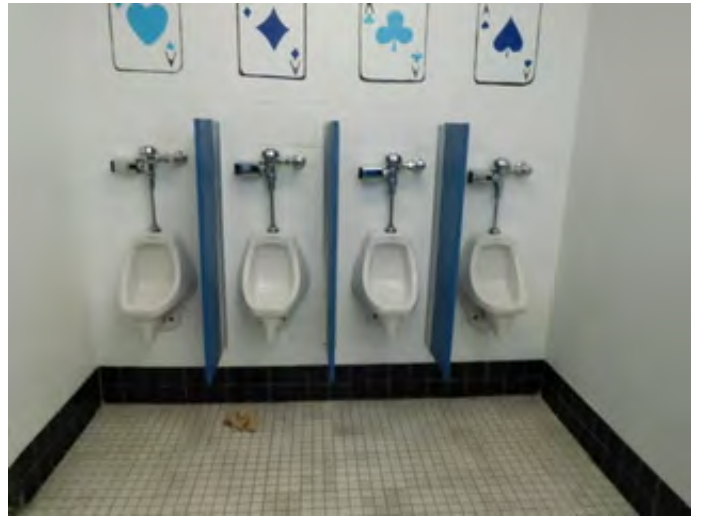
Typical Restroom Urinals

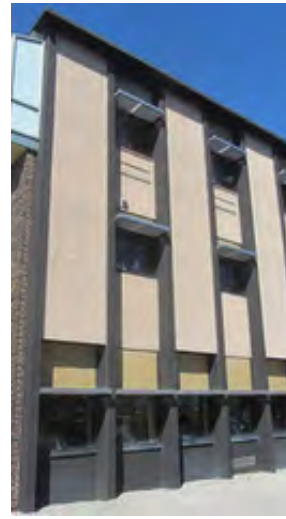
1963 Original Construction Classroom Windows

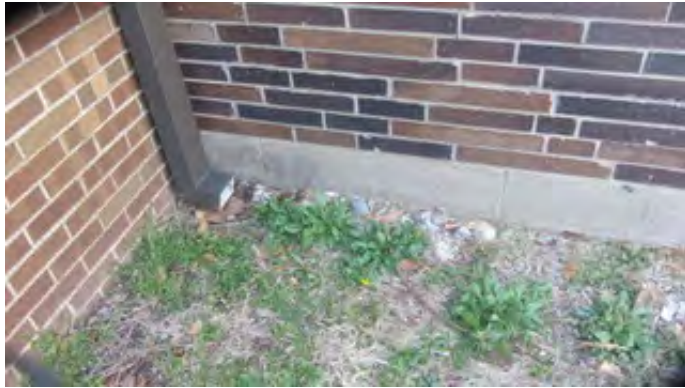
**Rating:** 2 Needs Repair

1963 Original Constructiton Exposed Foundation

**Recommendations:** Repair areas of cracking and open masonry joints in the 1963 Original Construction and 1988 Addition. Regrade depressed areas under emergency roof drains in the 1963 Original Construction. Repair leaks in Mechanical Room walls.

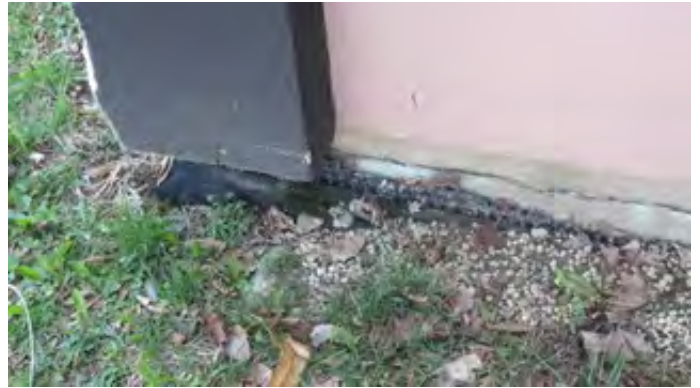
1999 Addition Foundation

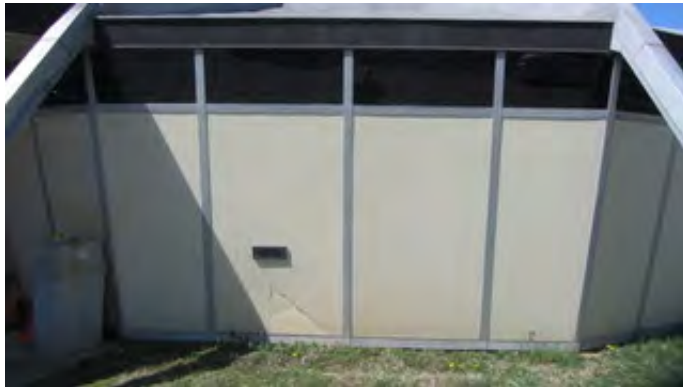
Insulated panels at 1963 Original Construction Music Room

<b>Other:</b> Exterior Masonry Repairs	\$15.00	sq.ft. (Qty)		5,894 Required	480 Required		940 Required	\$109,710.00	Repair exterior masonry as required throughout the overall facility.
<b>Other:</b> Galbestos Panel Replacement	\$50.00	sq.ft. (Qty)		3,264 Required				\$163,200.00	Replace Galbestos Panels in the 1963 Original Construction.
<b>Other:</b> Insulated Panel Replacement	\$50.00	sq.ft. (Qty)		4,392 Required	60 Required			\$222,600.00	Replace insulated metal panels in the 1963 Original Construction.
<b>Other:</b> Interior Masonry Repairs	\$15.00	sq.ft. (Qty)		4,420 Required		200 Required	470 Required	\$76,350.00	Repair interior masonry as required throughout the overall facility.
<b>Other:</b> Prep and Paint Exposed Concrete Structure	\$10.00	sq.ft. (Qty)		6,368 Required				\$63,680.00	Prep and paint exposed concrete structural elements in the 1963 Original Construction.
<b>Other:</b> Prep and Paint Exposed Steel Lintels	\$8.00	sq.ft. (Qty)		780 Required	60 Required	8 Required	214 Required	\$8,496.00	Prep and paint exposed steel lintels through the overall facility.

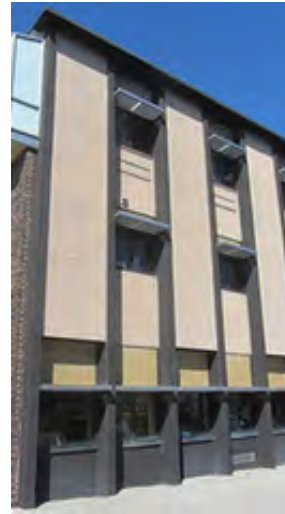
1963 Original Construction Three Story Structure

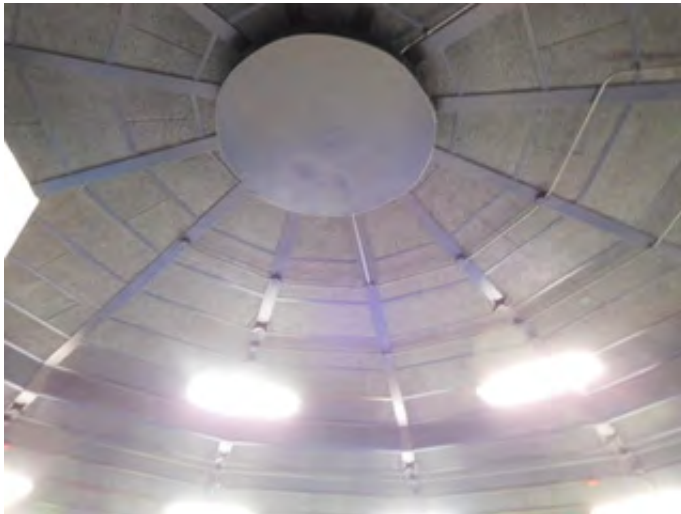
**Rating:** 2 Needs Repair

1963 Original Construction Music Room Roof Structure

**Recommendations:** Remove and replace wood floor, wall and roof construction in the 1988 Addition with code compliant construction that meets with Ohio School Design Manual Requirements. Provide funding for an investigation and correction of the structural issues at the intermediate floors of the 1963 Original Construction. Refer to Item A for funding of architectural soffits to accommodate HVAC, electrical, and plumbing scopes of work.

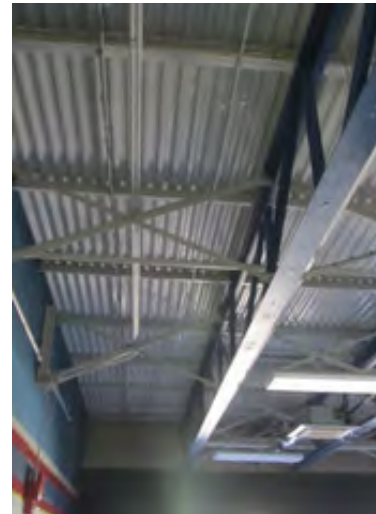
1963 Original Construction Student Dining Roof Structure

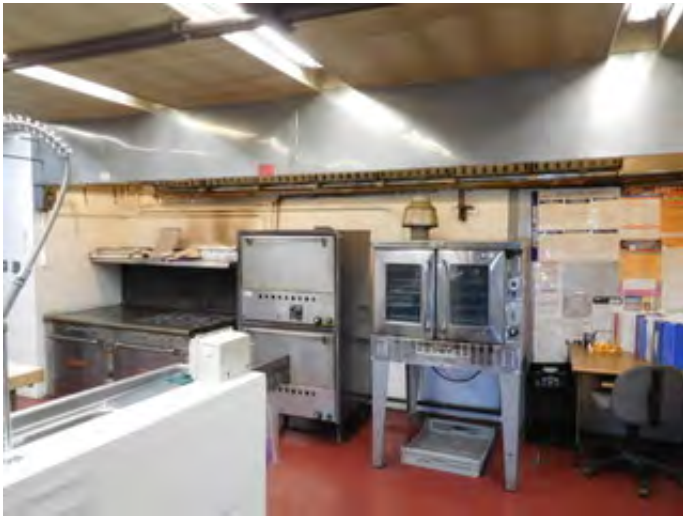
**Rating:** 3 Needs Replacement

Kitchen Hood & Equipment

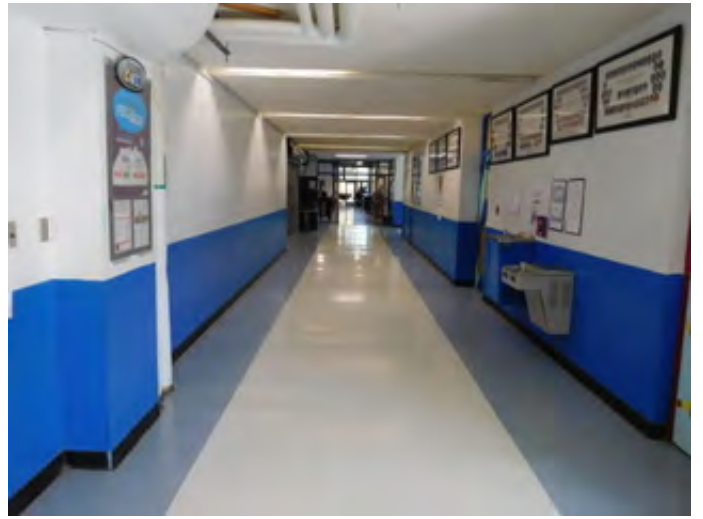
Typical Corridor Finishes

<b>Other:</b> Complete Replacement of Finishes and Casework (High):	\$17.70	sq.ft. (Qty)		34,664 Required			10,139 Required	\$793,013.10	(high school, per building area, with removal of existing)
<b>Other:</b> Complete Replacement of Finishes and Casework (Middle):	\$15.90	sq.ft. (Qty)		17,074 Required	6,914 Required		4,994 Required	\$460,813.80	(middle, per building area, with removal of existing)
<b>Other:</b> Interior Soffit Replacement	\$15.00	sq.ft. (Qty)		250 Required	100 Required			\$5,250.00	Replace gypsum board, acoustical tile, and preformed panel type interior soffits due to age and condition.
<b>Other:</b> Sound Control	\$3.00	sq.ft. (Qty)		12,833 Required				\$38,499.00	Provide for appropriate sound attenuation acoustical surface treatments in the Gymnasium, Student Dining, and Media Center.
<b>Other:</b> Stage Equipment	\$33,700.00	allowance		Required				\$33,700.00	Provide for Stage Equipment allowances due to age and condition.

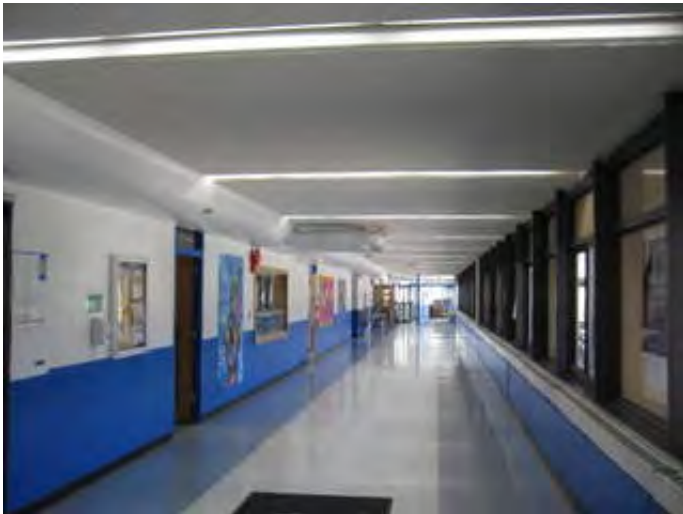
**Rating:** 3 Needs Replacement

Typical Corridor Fluorescent Light Fixtures

**Recommendations:** Provide complete replacement of lighting system due to age, condition, lighting levels, utilization of incandescent fixtures, lack of multilevel switching, and installation of systems outlined in Items A, C, J, and U.

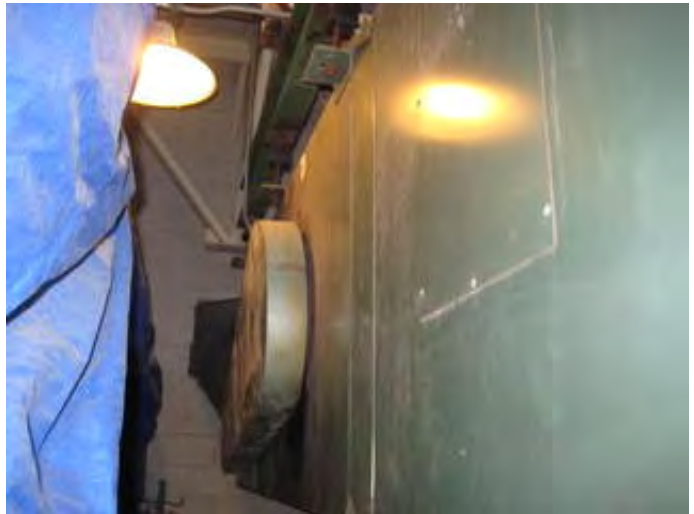
Service Area Incandescent Light Fixture

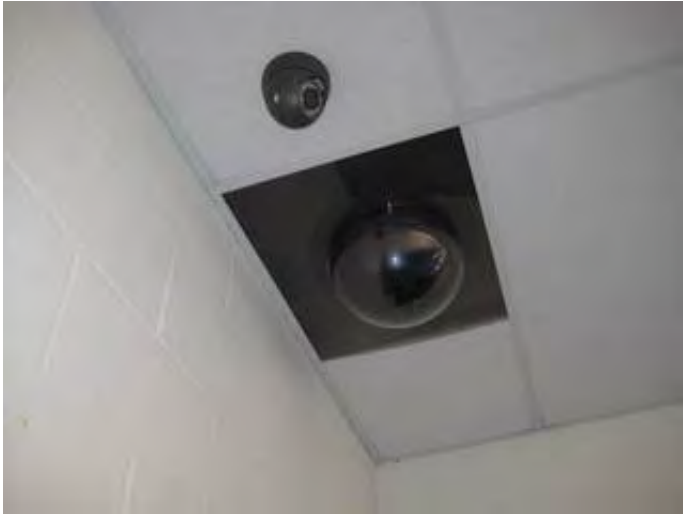
**Rating:** 3 Needs Replacement

Security System CCTV Camera

**Recommendations:** Provide complete replacement of security system to meet Ohio School Design Manual guidelines. Provide complete replacement of exterior site lighting system to meet Ohio School Design Manual guidelines. Provide OSDM-compliant playground fencing, funding included in complete replacement of security system. Provide a secure entrance Vestibule between the main entry area and Administrative Offices.

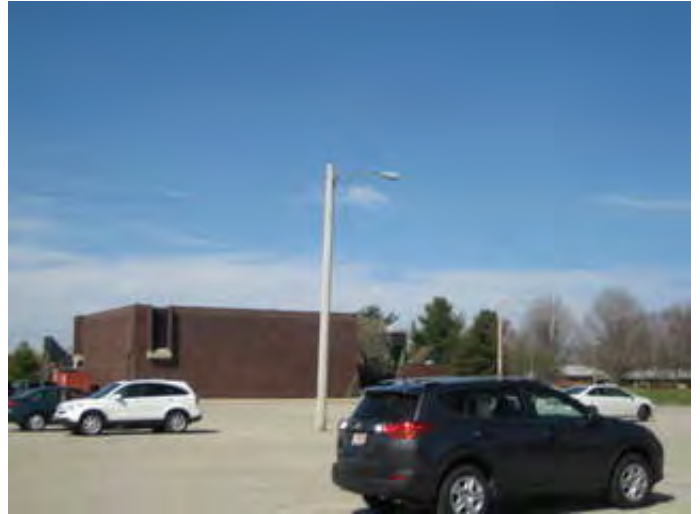
Pole Mounted HID High Pressure Sodium Light Fixture

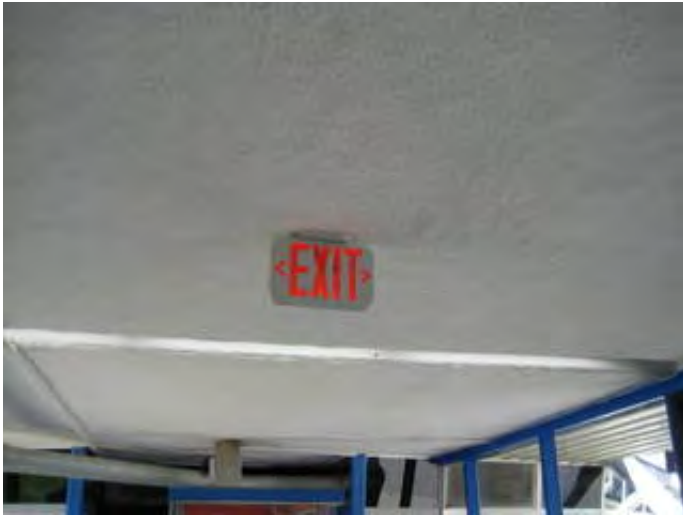
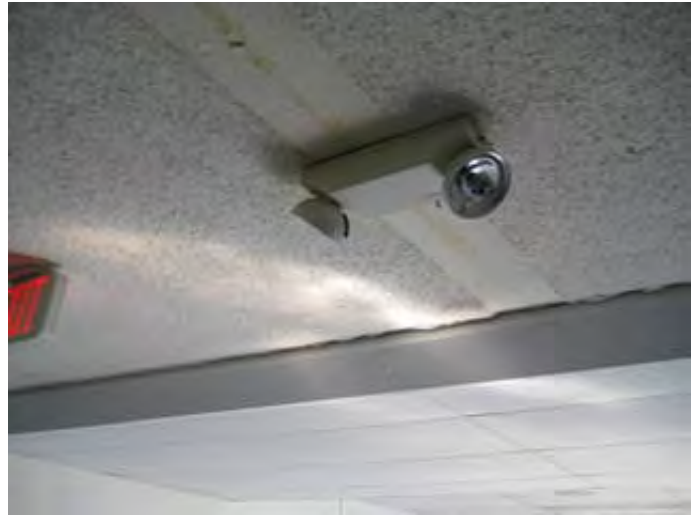
Exit Sign

Emergency Egress Light Fixture

**Recommendations:** Provide complete replacement of emergency / egress lighting system to meet Ohio School Design Manual and Ohio Building Code guidelines.

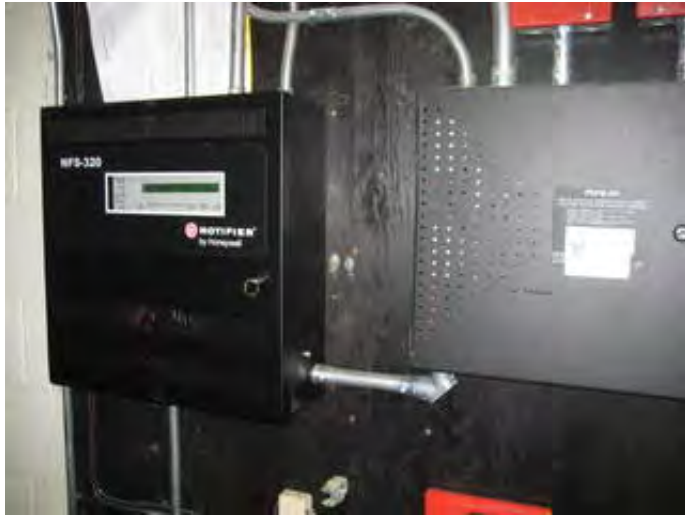
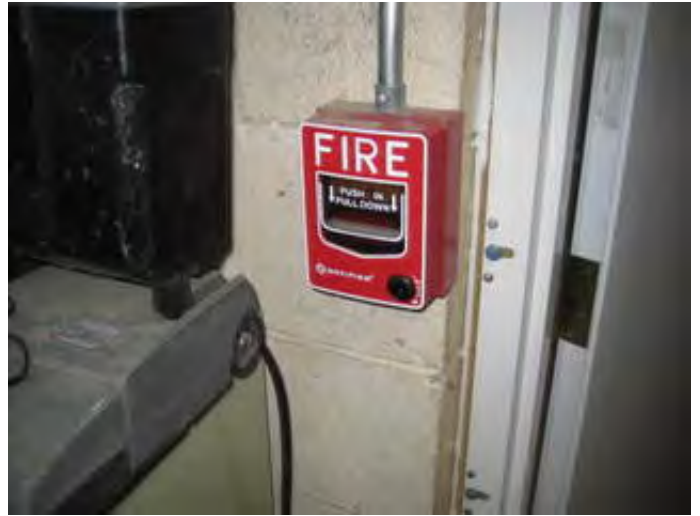
Fire Alarm System Control Panel

Fire Alarm System Manual Pull Station

**Recommendations:** Provide complete replacement of fire alarm system to meet OBC, NFPA, and Ohio School Design Manual guidelines.

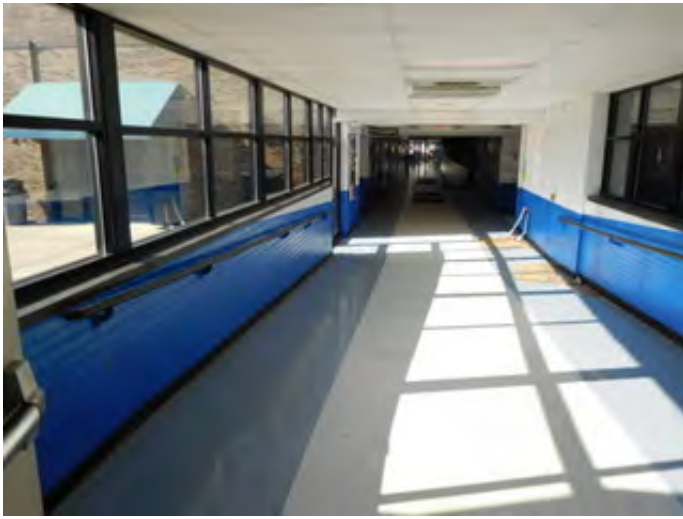
ADA Compliant Ramp

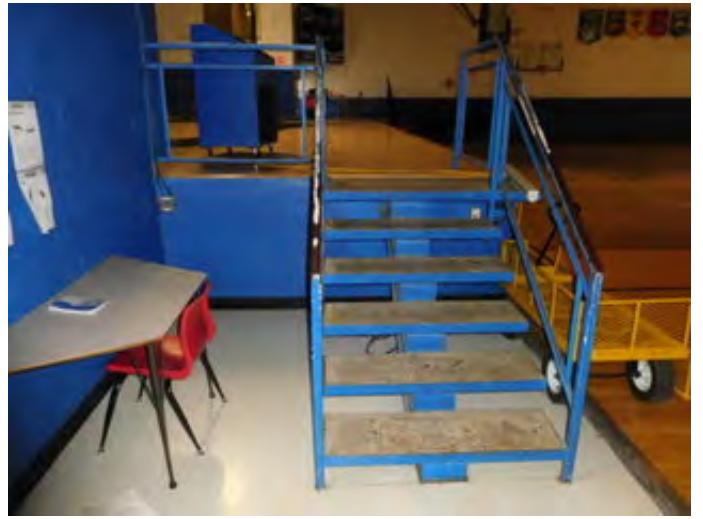
Non-ADA Compliant Stage Access

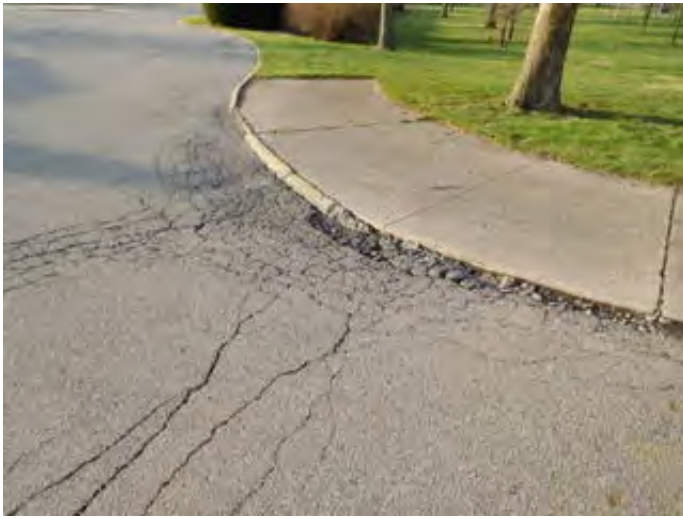
Asphalt, Curb, and Sidewalk Condition

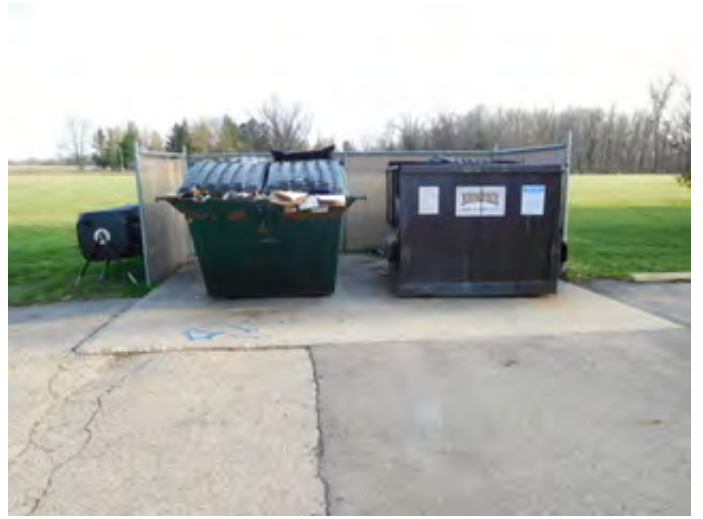
Concrete Dumpster Pad

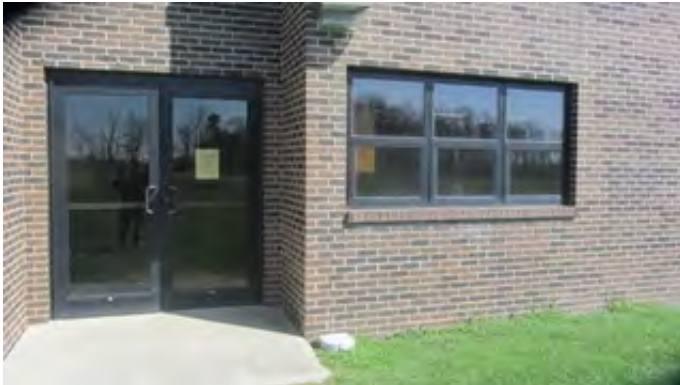
2002 Addition Exterior Door and Window

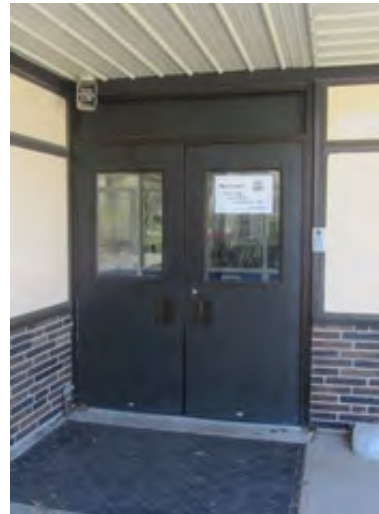
1963 Original Construction Main Entry Doors

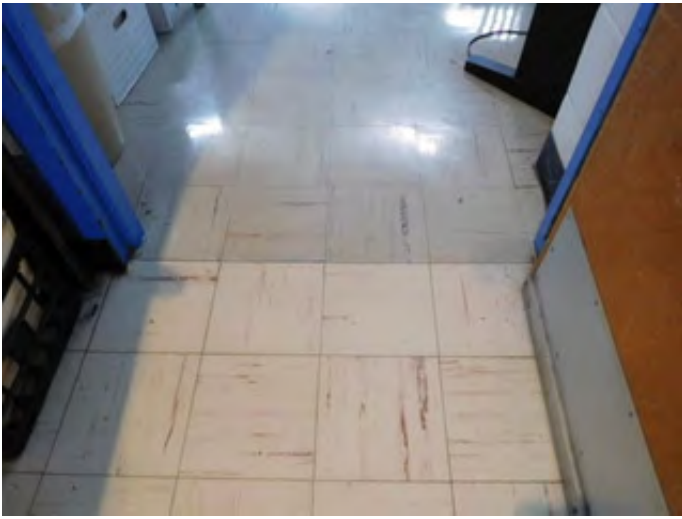
VAT Flooring

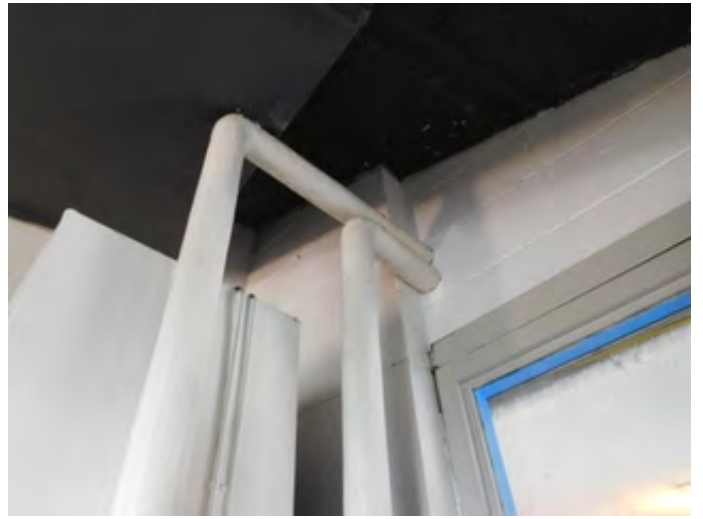
Pipe Insulation

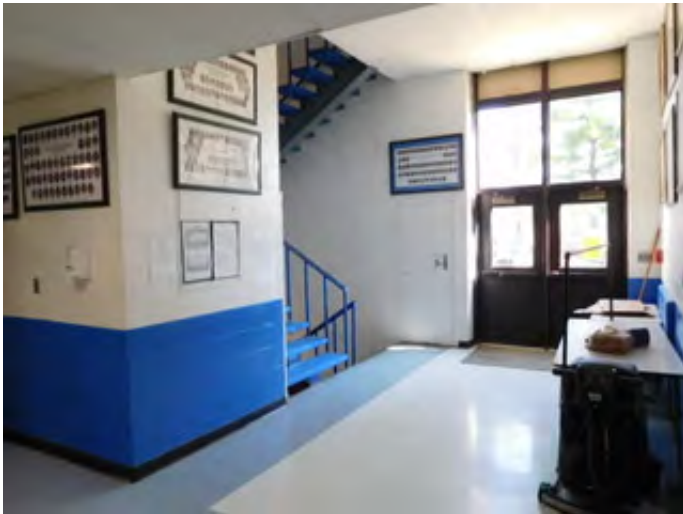
Existing Stair Tower with fire alarm No 2 hour Enclosure
