**Building Information - Yellow Springs Exempted Village (45674) - Mills Lawn Elementary / Middle School**

Program Type	Expedited Local Partnership Program (ELPP)
Setting	Small City
Assessment Name	Mills Lawn Elementary / Middle (24919) FINAL
Assessment Date (on-site; non-EEA)	2017-03-29
Kitchen Type	Full Kitchen
Cost Set:	2017
Building Name	Mills Lawn Elementary / Middle School
Building IRN	24919
Building Address	200 South Walnut Street
Building City	Yellow Springs
Building Zipcode	45387
Building Phone	(937) 767.7217
Acreage	8.84
Current Grades:	K-6
Teaching Stations	25
Number of Floors	2
Student Capacity	378
Current Enrollment	374
Enrollment Date	2017-03-29
Enrollment Date is the date in which the current enrollment was taken.	
Number of Classrooms	23
Historical Register	<b>NO</b>
Building's Principal	Mr. Matthew Housh
Building Type	Elementary/Middle

**Building Construction Information - Yellow Springs Exempted Village (45674) - Mills Lawn Elementary / Middle School (24919)**

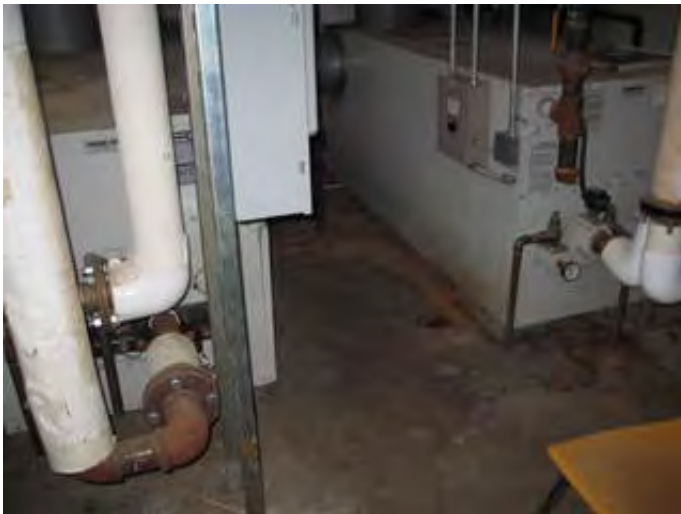
**Description:** The existing system for the 1952 Original Construction is a natural gas fired heated water boiler type system, installed in 1952, and is in fair condition. The system in the 1957 Addition is an extension of that found in the 1952 Original Construction. The existing system for the 2002 Addition is a natural gas fired packaged roof top unit type system, installed in 2002, and is in fair condition. 2-pipe vs. 4-pipe designations are not applicable in this facility, as no central air conditioning is provided. The 1952 Original Construction is equipped with (2) Copper-fin II boilers, manufactured by Lochinvar, are believed to be installed in 1998, and are in fair condition. Heating water is distributed to terminal units consisting of unit ventilators, cabinet heaters, unit heaters, fin tubes, air handlers, and roof top units. The 2002 Addition is equipped with (2) ducted packaged roof top units (with DX cooling and natural gas/hot water heat), manufactured by York, were installed in 2002, and are in fair condition. Heated air is distributed to terminal units consisting of multiple VAV boxes. All terminal equipment is original to each addition and is in fair condition. The system does not appear to comply with the 15 CFM per person fresh air requirements of the Ohio Building Code mechanical code and Ohio School Design Manual. The pneumatic, digital, and DDC type system temperature controls are original to each addition, with incremental upgrades, and are in fair to poor condition. The system does not feature individual temperature controls in all spaces required by the OSDM. The overall system does not feature any central energy recovery systems. The 1952 Original Construction is not equipped with widespread louvered interior doors to facilitate Corridor utilization as return air plenums. The remainder of the overall facility is not equipped with louvered interiors doors. The existing system is ducted in the 2002 Addition and a portion of the 1952 Original Construction and 1957 Addition, but the ductwork cannot be integrated into a possible future system due to arrangement, air volume, and routing of existing ductwork. The existing system is not ducted in the remainder of the overall facility, and floor to structural deck heights will accommodate the installation of properly sized ductwork for a future Ohio School Design Manual approved system. The overall heating system is evaluated as not being in safe and efficient working order, and long term life expectancy of the existing system is not anticipated. The structure is not equipped with central air conditioning. The site does not contain underground fuel tanks.

**Rating:** 3 Needs Replacement

Natural Gas Fired Heated Water Boilers

**Recommendations:** Provide new overall heating, ventilating, and air conditioning system to achieve compliance with Ohio Building Code and Ohio School Design Manual standards. Replace existing ductwork in the 2002 Addition and a portion of the 1952 Original Construction and 1957 Addition to facilitate efficient exchange of conditioned air. Convert to ducted system the remainder of the overall facility to facilitate efficient exchange of conditioned air.

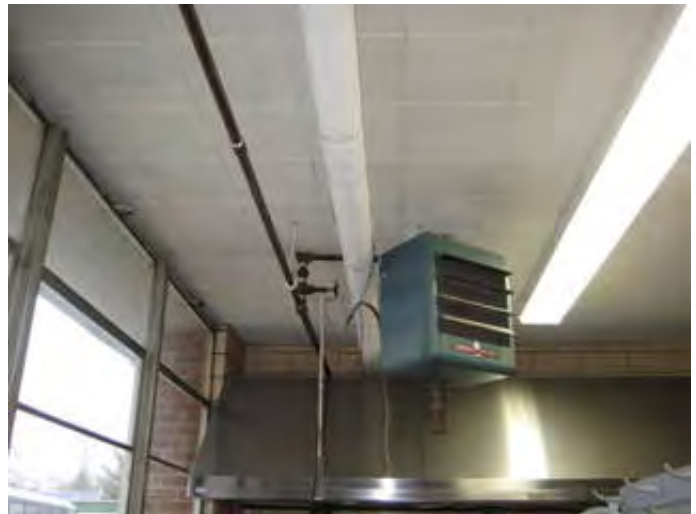
Unit Heater

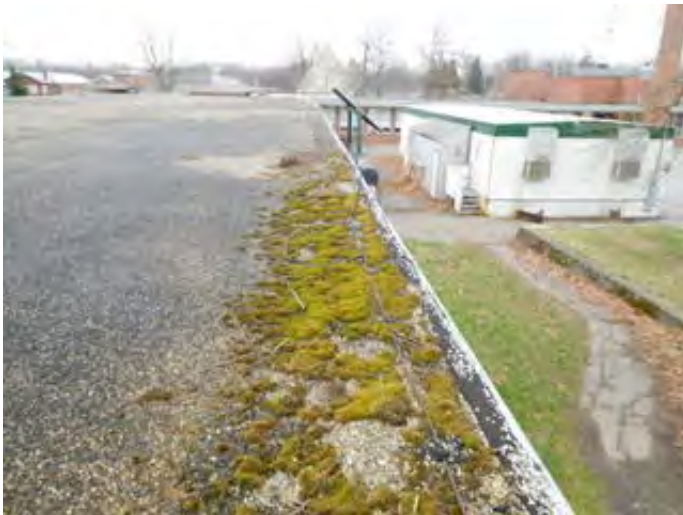
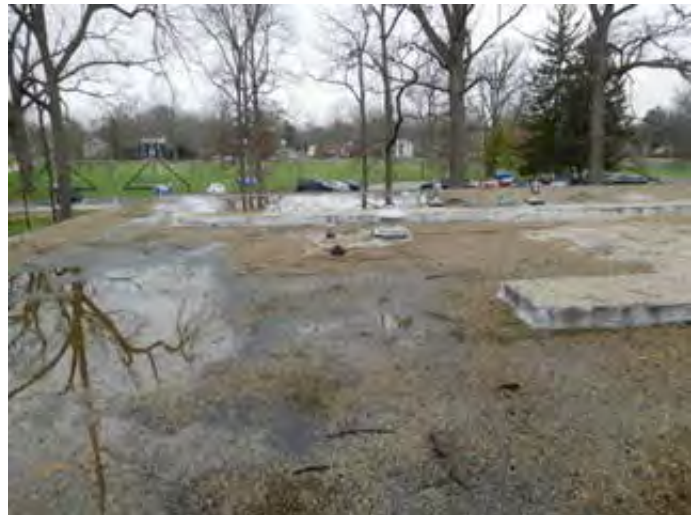
**Description:** The roof over the Original Construction is a built-up system with gravel ballast that was installed in 1952, and is in poor condition. The roof over the 1957 Addition is a built-up system with gravel ballast that was installed in 1957, and is in poor condition. The roof over the 2002 Addition is a built-up system with gravel ballast that was installed in 2002, and is in fair condition. There are no District reports of current leaking. No signs of past leaking were observed during the physical assessment. Access to the roof was gained by access hatch that is in poor condition. Fall safety protection cages are not required, and are not provided. There were observations of standing water on the roof. Metal cap flashings and copings are in fair to poor condition. Roof storm drainage is addressed through a system of roof drains, which are properly located, and in fair to poor condition. The roof of the Original Construction and the 1957 Addition are not equipped with overflow roof drains though they will be required in areas of roof replacement. No problems requiring attention were encountered with any roof penetrations. There are not any covered walkways attached to this structure.

**Rating:** 3 Needs Replacement

Built-Up Roof with Gravel Ballast

**Recommendations:** The roof over the overall facility requires replacement to meet Ohio School Design Manual guidelines due to condition and age of system and projected lifecycle. The flashing and coping on the overall facility require replacement due to condition. Due to existing conditions roof drains require replacement on the overall facility with the exception of the 2002 Addition. Due to age and condition replace the existing access ladder and hatch. Provide two new roof access ladders. Replace existing roof drains and sumps due to condition and replacement of the roofing system. Provide new overflow roof drains and piping.

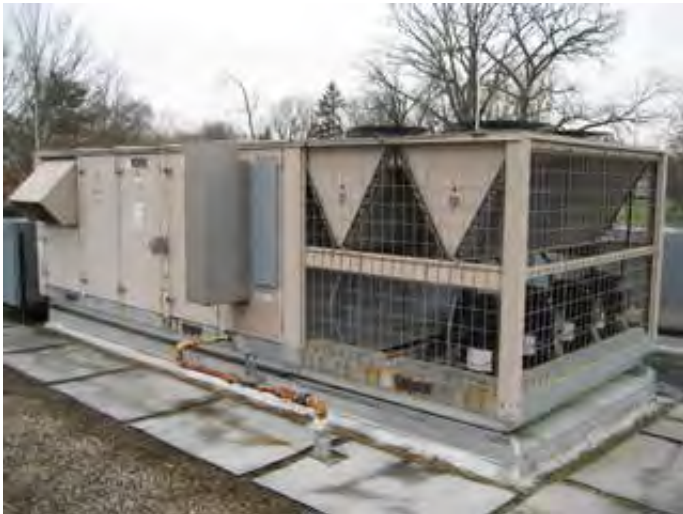
**Description:** The overall facility is not equipped with a central air conditioning system. Window units are provided at multiple Classroom locations throughout the overall facility, as well as in the Teacher's Lounge. An isolated room system consisting of ductless split AC wall cassettes with (2) condensing units (pad mounted and located on the exterior) is provided in the Administrative Offices in the 1952 Original Construction. An isolated room system consisting of a single ducted HVAC/furnace type unit and (1) condensing unit (pad mounted and located on the exterior) is provided in the Administrative Office Conference Room of the 2002 Addition. An isolated room system consisting of (2) ducted packaged air cooled York roof top units (with DX cooling and natural gas/hot water heat) is provided in the majority of the 2002 Addition and the Multi-Purpose Room (Gymnasium/Student Dining) and Media Center of the 1952 Original Construction. The ventilation system in the overall facility consists of unit ventilators and roof top units, original to each addition and in fair condition, providing fresh air to Classrooms, and air handlers and roof top units, original to each addition and in fair condition, providing fresh air to other miscellaneous spaces such as Multi-Purpose Room (Gymnasium/Student Dining) and Media Center. Relief air venting is provided by louvered interior doors, ceiling plenums / being ducted back through energy recovery units, central relief fans, air handlers, and roof top units. The ventilation system does not meet the Ohio Building Code 15 CFM per occupant fresh air requirement. The overall system is not compliant with Ohio Building Code and Ohio School Design Manual requirements. Dust collection systems are not required in this facility though no system is provided. The Art program is equipped with a kiln, and existing kiln ventilation is inadequate, and in fair condition. General building exhaust systems for Restrooms, Storage Rooms, Art Rooms, and Custodial Closets are inadequately placed, and in fair condition.

**Rating:** 2 Needs Repair

Roof Top Unit

**Recommendations:** Provide an air conditioning system to meet with Ohio Building Code and Ohio School Design Manual requirements. Replace general building exhaust systems located in Restrooms, Storage Rooms, and Custodial Closets. Pricing included in Item A. Replace the existing Art Program's kiln ventilation system due to age, condition, and lack of OSDM compliance.

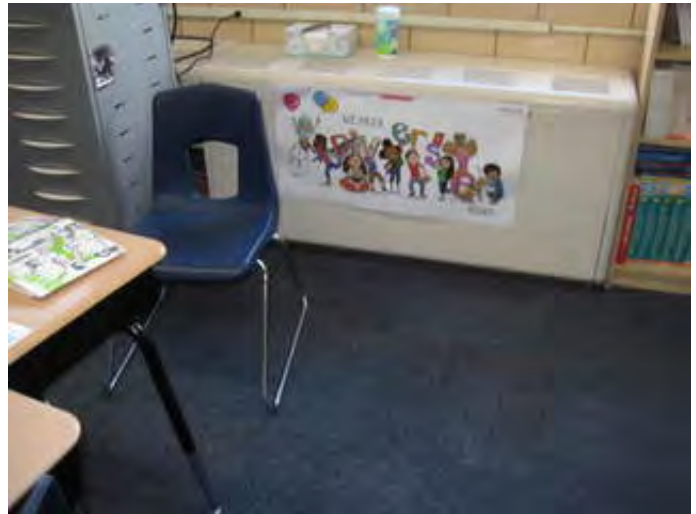
Unit Ventilator

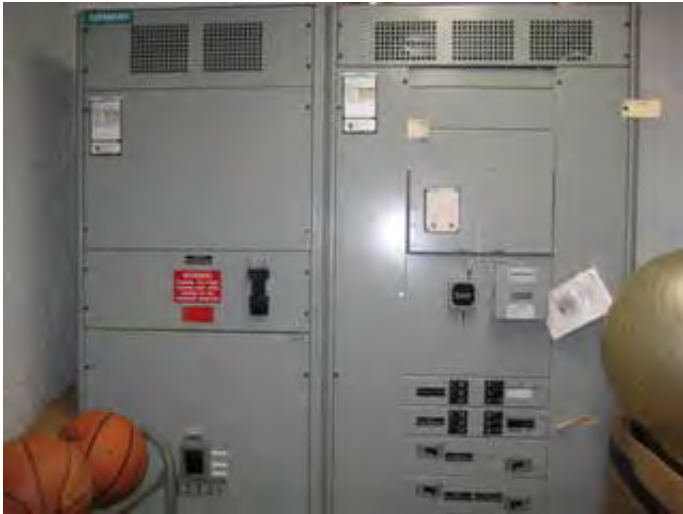
**Description:** The electrical system provided to the 2002 Addition is a 208Y/120 volts, 1,200 amp, 3 phase and 4 wire system installed in 2002, and is in good to fair condition. The systems in the 1952 Original Construction and 1957 Addition are an extension of that found in the 2002 Addition. Power is provided to the school by a single utility owned, pad-mounted transformer located at the front of the School, and in fair condition. The panel systems are original to each Addition, are in fair condition, and for the most part cannot be expanded to add additional capacity. The Classrooms are not equipped with adequate electrical outlets. The typical Classroom contains (5) general purpose outlets, (0) dedicated outlets for each Classroom computer, and (1) dedicated outlet for each Classroom television/ceiling mounted projector. Some Classrooms are equipped with as many as (6) general purpose outlets, while others are equipped with as few as (3) general purpose outlets. There are not any spaces that have no electrical outlets. The Corridors are equipped with adequate electrical outlets for servicing. Adequate GFI protected exterior outlets are not provided around the perimeter of the building. The facility is not equipped with an emergency generator. Adequate lightning protection safeguards appear to be provided and are in fair condition. Stage lighting power system including control panel, breakers, and dimmers is inadequately provided, in fair condition and does not meet OSDM requirements. The overall electrical system does not fully meet Ohio School Design Manual requirements in supporting the current needs of the school, and will be inadequate to meet the facility's future needs.

**Rating:** 3 Needs Replacement

Main Electrical Distribution Panel

**Recommendations:** The entire electrical system requires replacement to meet Ohio School Design Manual guidelines for overall capacity due to age, condition, lack of OSDM-required features, and to accommodate the addition of an air conditioning system. Provide an emergency generator, with funding included in the electrical system replacement. Replace the existing lightning protection safeguards in the overall facility, including associated grounding system, with funding included in the electrical system replacement.

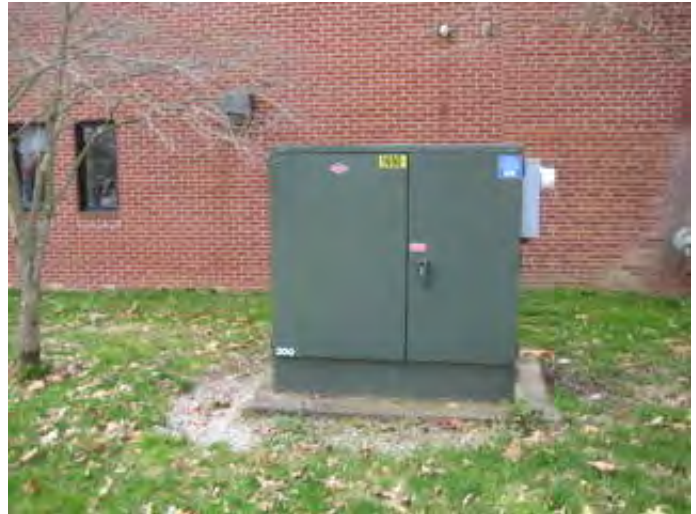
Pad Mounted Transformer

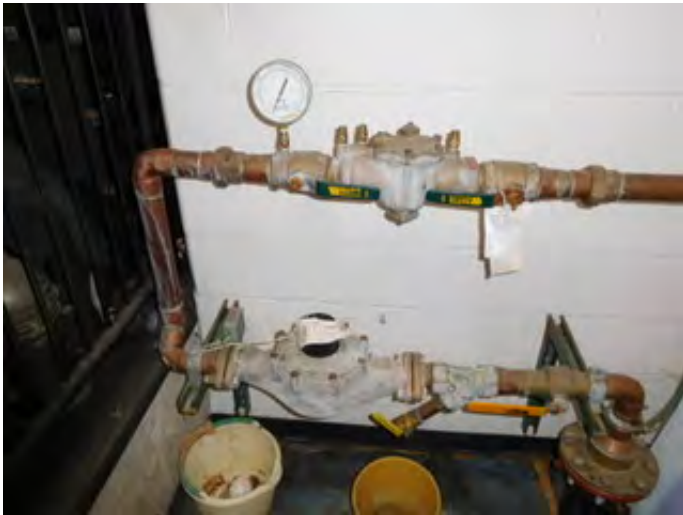
Description:	<p>The service entrance is equipped with a reduced pressure back flow preventer in fair condition. A water treatment system is not provided, though none is needed. The domestic water supply piping in the overall facility is copper and galvanized, is original to each addition, and is in fair condition. The waste piping in the overall facility is cast iron and galvanized, is original to each addition, and is in fair condition. The facility is equipped with a 71 gallon gas water heater in good condition. The school contains 2 Large Group Restrooms for boys, 2 Large Group Restrooms for girls, 0 Locker Room Restrooms for boys, 0 Locker Room Restrooms for girls, 3 Restrooms associated with specialty Classrooms, 8 Restrooms for Individual Classrooms, and 5 Restrooms for staff. Boys' Large Group Restrooms contain 2 ADA and 1 non-ADA wall mounted flush valve toilets, 6 ADA and 1 non-ADA wall mounted flush valve and waterless urinals, as well as 2 ADA wall mounted lavatories and 2 non-ADA countertop lavatories. Girls' Large Group Restrooms contain 2 ADA and 6 non-ADA wall mounted flush valve toilets, as well as 2 ADA wall mounted lavatories and 2 non-ADA countertop lavatories. Individual Classroom Restrooms contain 2 ADA and 7 non-ADA wall and floor mounted flush valve toilets, 2 ADA wall mounted urinals, as well as 3 ADA and 4 non-ADA countertop and wall mounted lavatories. Staff Restrooms contain 2 ADA and 2 non-ADA wall mounted flush valve toilets, 1 non-ADA floor mounted tank type toilet, as well as 2 ADA and 3 non-ADA wall mounted lavatories. Condition of fixtures is good to fair. The facility is equipped with 2 ADA and 4 non-ADA electric water coolers, in good to fair condition. The 22 Elementary Classrooms are not equipped with sink mounted type drinking fountains. Special Education Classroom is equipped with the required Restroom facilities, and fixtures are in good to fair condition. Kitchen is equipped with the required Restroom, and fixtures are in fair to poor condition. Heath Clinic is equipped with the required Restroom, and fixtures are in fair to poor condition. Kindergarten / Pre-K Classrooms are equipped with Restroom facilities, and fixtures are in poor condition. Kitchen fixtures consist of 1 single compartment sink, 1 double compartment sink, and 1 triple compartment sink, which are all in fair condition. The Kitchen is not equipped with a grease interceptor. The Kitchen is provided the required 140 degree hot water supply. The school does not full meet the OBC requirements for fixtures. Relative to LEED requirements, the school is not equipped with low flow type fixtures, but is equipped with waterless urinals. Per OBC and OSDM requirements this facility should be equipped with 6 toilets, 2 urinals, 8 lavatories, 22 Classroom sink mounted drinking fountains, and 4 electric water coolers. Observations revealed that the school is currently equipped with 30 toilets, 9 urinals, 26 lavatories, 5 Classroom sink mounted drinking fountains, and 6 electric water coolers. ADA requirements are not met for fixtures and drinking fountains see Item O. Custodial Closets are properly located and are adequately provided with required service sinks or floor drain sinks, which are in fair to poor condition. Science Classrooms are not equipped with required utility sink, gas / compressed air connections, and safety shower / eyewash. Due to existing grade configuration, no Biology or Chemistry Classroom acid waste systems are required. Adequate exterior wall hydrants are not provided.</p>

Incoming Domestic Water Service Backflow Preventer

Rating:	3 Needs Replacement
Recommendations:	<p>Due to age, condition, LEED, and OBC and OSFC requirements, provide 23 new toilets, 21 new lavatories, 3 new electric water coolers, 22 new lavatory mounted type drinking fountains. Replace water supply and sanitary waste piping in the 1952 Original Construction and the 1957 Addition due to age and condition. Replace reduced pressure back flow preventer due to age and condition. Provide for the replacement and addition of exterior hose bibs to meet OSDM Standards. Provide funding for a new grease trap in the kitchen. Provide funding for a new grease interceptor in the art classroom. See Item J for replacement of kitchen fixtures. See Item O for replacement of fixtures related to ADA requirements. Provide the Science Classroom with the required utility sink, gas connections, compressed air connections, and safety shower / eyewash stations. Provide required sink mounted type drinking fountains in Elementary Classroom spaces.</p>

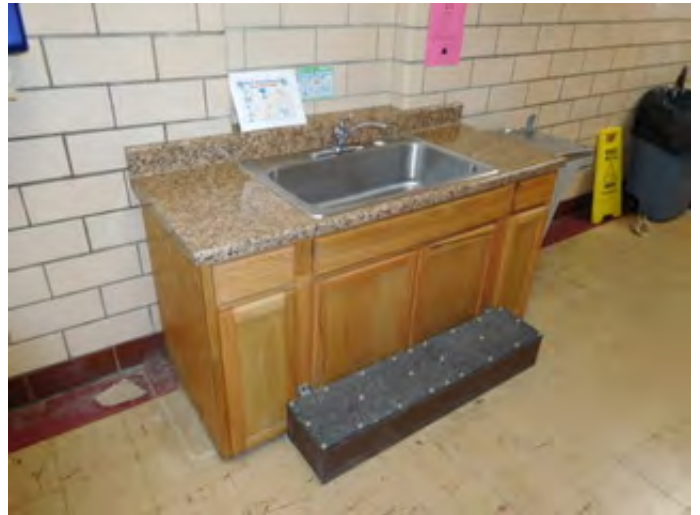
Classroom Sink

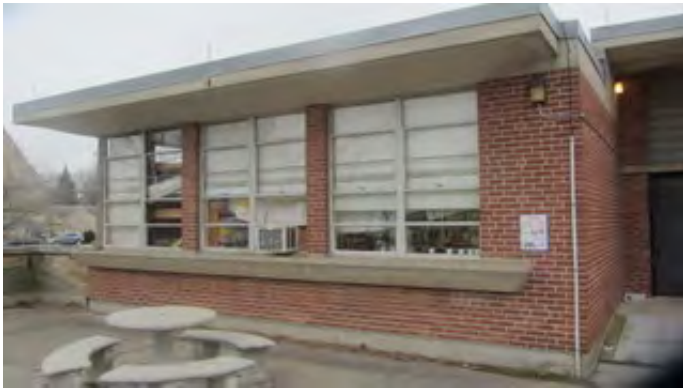
The 1952 Original Construction is equipped with an aluminum frame window with single glazed type window system, which was installed in 1952, and is in poor condition. The window system features operable windows throughout most portions of the building, and operable windows are equipped with opening limiters in poor condition and insect screens where provided in fair to poor condition. Window system seals are in poor condition, with frequent air and water infiltration being experienced. Window system hardware is in poor condition. The 1957 Addition is equipped with an aluminum frame window with double glazed insulated glazing and insulated panel type window system, and is in fair condition. Date of installation was not available. The window system features operable windows throughout most portions of the building, and operable windows are equipped with opening limiters in fair condition and insect screens where provided in fair condition. Window system seals are in fair condition. The District reported that moderate air and water infiltration is being experienced. Window system hardware is in fair condition. The 2002 Addition is equipped with thermally broken aluminum frame windows with double glazed insulated glazing type window system, which was installed in 2002, and is in good condition. The window system features operable and inoperable windows throughout the building, and operable windows are equipped with opening limiters in good condition and insect screens in good condition. Window system seals are in good condition, with no air and water infiltration being experienced. Window system hardware is in good condition. The window systems in the overall facility feature surface mounted shades, which are in fair condition. The window system in the 2002 Conference Room Addition feature surface mounted vertical blinds in fair condition. This facility is not equipped with any curtain wall systems. There are glass block windows in the 1952 Original Construction, in fair condition. The exterior doors in the 1952 Original Construction are equipped with aluminum frame transoms with insulated FRP panels, in good to fair condition and wood frame transoms with single pane glazing in poor condition. Exterior door vision panels in the FRP doors are tempered double glazed insulated glazing in good to fair condition. Exterior door vision panels in the wood doors are single pane wire glazing in poor condition. The exterior doors in the 1957 Addition are equipped with aluminum frame sidelights and transoms with tempered double glazed insulated glazing and insulated metal panels in good to fair condition. Exterior door vision panels are tempered double glazed insulated glazing, in good to fair condition. The exterior doors in the 2002 Addition are equipped with aluminum frame sidelights and transoms with tempered double glazed insulated glazing, in good condition. Exterior door vision panels are tempered single pane glazing. The school does contain 2 skylights which are equipped with aluminum frames and insulated fiberglass panels, in good condition. The school does not contain any clerestories. Interior glass is OSDM-compliant. Window security grilles are not provided for ground floor windows. There is a 94 SF Greenhouse in the 1957 Addition, and it is in poor condition.

3 Needs Replacement

1952 Original Construction Typical Classroom Windows

Replace the existing non-insulated window system with a new insulated window system with integral blinds to meet with Ohio School Design Manual requirements in the 1952 Original Construction. Replace the existing glass block with a new insulated window system with integral blinds to meet with Ohio School Design Manual requirements in the 1952 Original Construction. Replace the existing insulated window system in the 1957 Addition due to condition with a new insulated window system with integral blinds to meet with Ohio School Design Manual requirements. Replace the existing insulated panel system in the 1957 Addition due to condition with a new insulated panel system. Replace non-insulated glazing in transoms and sidelights at exterior doors in the 1952 Original Construction and 1957 Addition. Replace existing greenhouse in the 1957 Addition due to condition. Replace single glazed door vision panels in the 2002 Addition. Replace blinds in the 2002 Addition.

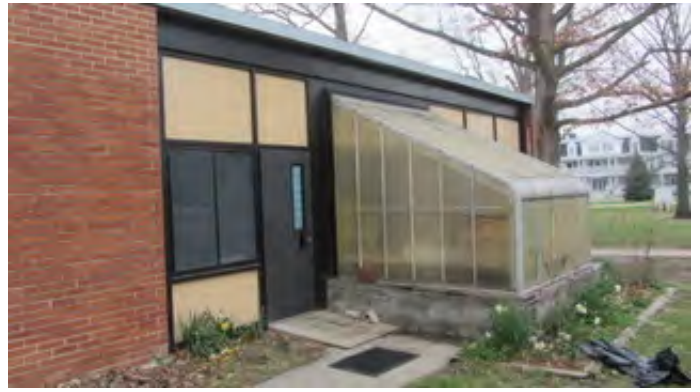
1957 Addition Typical Window System and Greenhouse

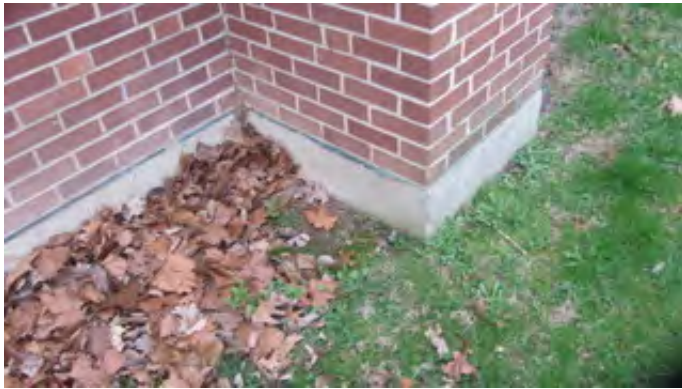
**Description:** The overall facility is equipped with concrete foundation walls on concrete spread footings, which displayed no locations of significant differential settlement, cracking, or leaking, and are in good to fair condition. Areas of minor cracking and spalling were observed through the overall facility. The District reports that there has been no past leaking due to foundation issues. No grading or site drainage deficiencies were noted around the perimeter of the structure that are contributing or could contribute to foundation or wall structural deterioration.

**Rating:** 2 Needs Repair

Typical 1952 Original Construction Exposed Foundation

**Recommendations:** Repair areas of cracking and spalling through the overall facility.

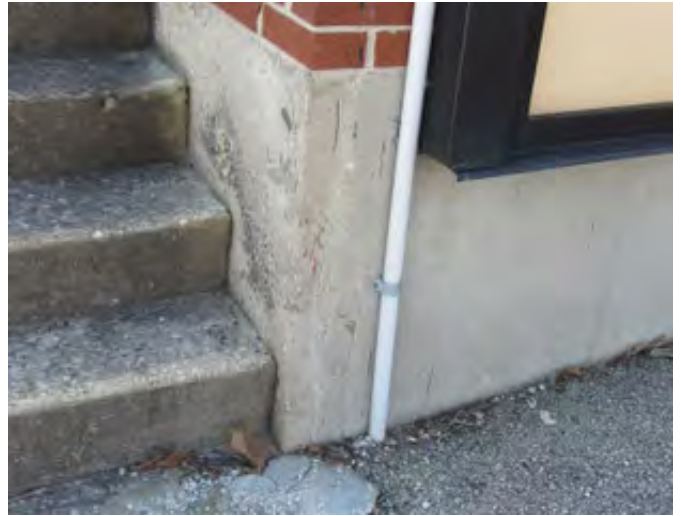
1957 Addition Exposed Concrete Foundation

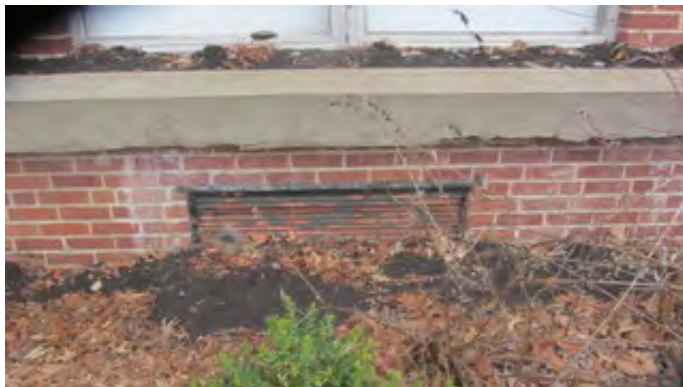
1952 Original Construction Window Sill and Unit Ventilator Opening

<b>Other:</b> Exterior Masonry Repairs	\$15.00	sq.ft. (Qty)		1,380 Required	228 Required	1,423 Required	\$45,465.00	Repair exterior masonry as required through out the overall facility.
<b>Other:</b> Interior Masonry Repairs	\$15.00	sq.ft. (Qty)		1,100 Required	180 Required	1,140 Required	\$36,300.00	Repair interior masonry as required through out the overall facility.
<b>Other:</b> Masonry Infill	\$27.00	sq.ft. (Qty)		48 Required			\$1,296.00	Provide masonry infill in the 1952 Original Construction.
<b>Other:</b> Prep and Paint Exposed Steel Lintels	\$8.00	ln.ft.		60 Required	218 Required	205 Required	\$3,864.00	Prep and paint exposed steel lintels through the overall facility.
<b>Other:</b> Repair Concrete Steps and Walls	\$50.00	sq.ft. (Qty)		280 Required			\$14,000.00	Repair concrete steps and walls at the 1952 Original Construction Mechanical Room Entry.
<b>Other:</b> Repair Concrete Window Sills	\$20.00	sq.ft. (Qty)		1,118 Required			\$22,360.00	Repair concrete window sills in the 1952 Original Construction.

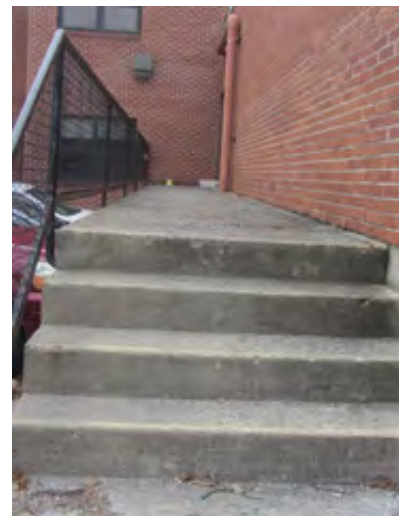
1957 Addition Concrete Walkway

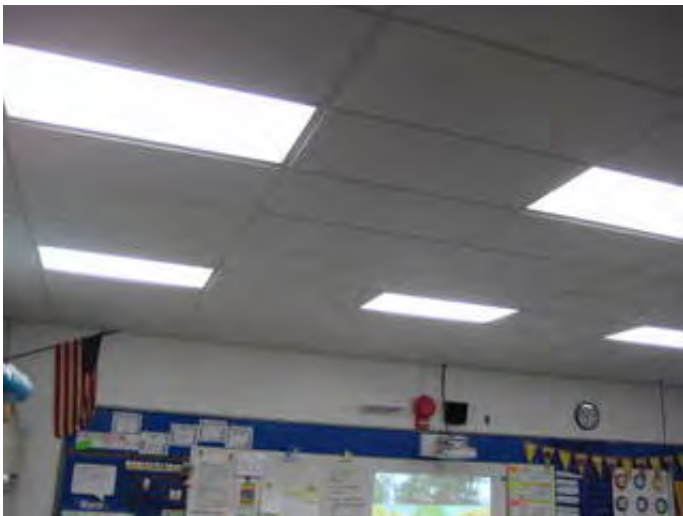
**Rating:** 3 Needs Replacement

Typical Fluorescent Classroom Light Fixtures

**Recommendations:** Provide complete replacement of lighting system due to age, condition, lighting levels, utilization of incandescent fixtures, lack of multilevel switching, and installation of systems outlined in Items A, C, J, and U.

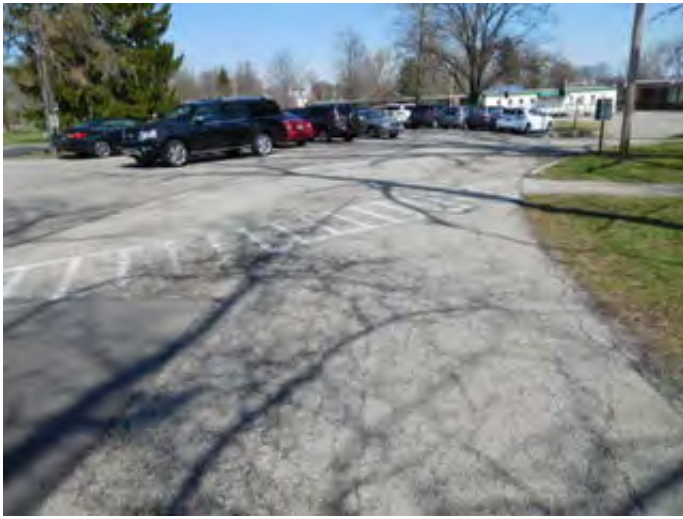
Asphalt Condition
