Property Inspection Report

Prepared for: School Comitee

High Rise lower entrance area Exterior

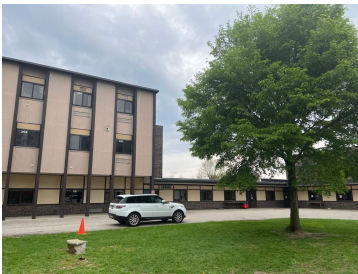
- ☐ ☐ ☒ ☐ Fascia: Aluminum >>> Fascia damaged in the food delivery
☐ ☐ ☒ ☐ Soffits: Aluminum >>> Not sealed with birds entering through the unsealed undulations in the roof decking

- ☐ ☐ ☐ ☒ Surface: Aluminum Panels(FAQ-Exterior) >>> Two panels above Jorge are rusted through requiring replacement

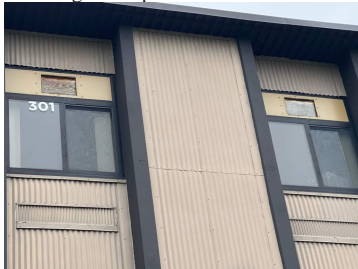
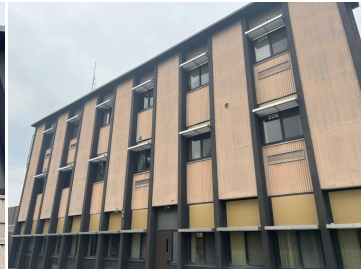
- ☐ ☐ ☒ ☐ Surface: Galvanized Panels >>> Modified panel(s) where AC units were removed (allowing moisture intrusion, possible concealed damage to substrate)
 One wall air conditioner installed in the sheet-metal panel
 Area underneath bay window bump out is not finished with a water resistant membrane (moisture damage possible)
 Some panels are slightly loose
 Exposed wood with patches at the bottom of some of the panels
 Caulking and repaint recommended

3. High Rise lower entrance area Exterior Surface: Galvanized Panels >>> Modified panel(s) where AC units were removed (allowing moisture intrusion, possible concealed damage to substrate)
One wall air conditioner installed in the sheet-metal panel
Area underneath bay window bump out is not finished with a water resistant membrane (moisture damage possible)
Some panels are slightly loose
Exposed wood with patches at the bottom of some of the panels
Caulking and repaint recommended

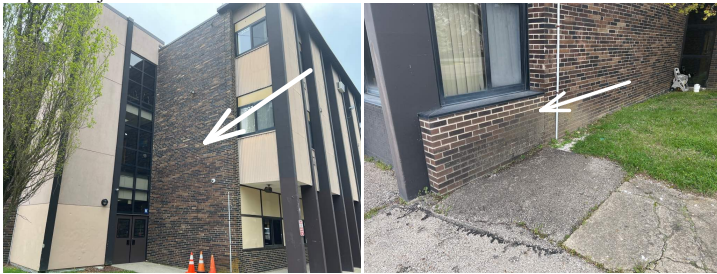
- ☐☐☐☐☒ Surface: Brick(FAQ-Exterior) >>> End wall by the stair well may still not be secured to the buildings framing as required
 What appears to be a loadbearing steel plate outside window 117 supports the brick is failing
 Roof rain water pouring down the side of building close to door D : may affect foundation overtime
 Expansion joint not sealed below window front left corner

2. High Rise lower entrance area Exterior Surface: Brick(FAQ-Exterior) >>> End wall by the stair well may still not be secured to the buildings framing as required
What appears to be a loadbearing steel plate outside window 117 supports the brick is failing
Roof rain water pouring down the side of building close to door D : may affect foundation overtime
Expansion joint not sealed below window front left corner

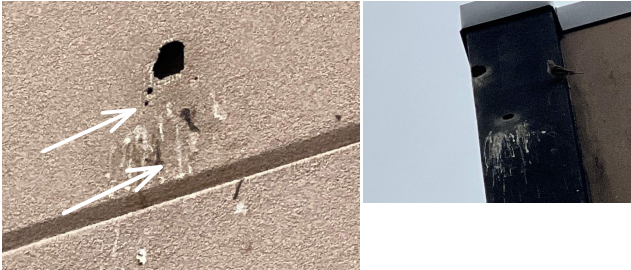
Surface: Exterior Insulated Finishing System (EIFS Stucco) (FAQ-Exterior) >>> Damaged areas on the lower panels: this is a poor choice of product for the lowest eight feet

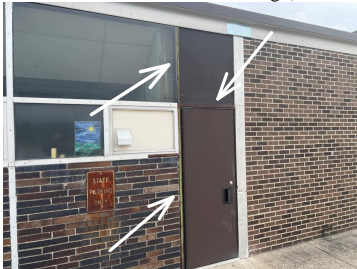
- ☐☐☐☒ Trim: Aluminum >>> Missing (water damage possible) at door beside 112

4. High Rise lower entrance area Exterior Trim: Aluminum >>> Missing (water damage possible) at door beside 112

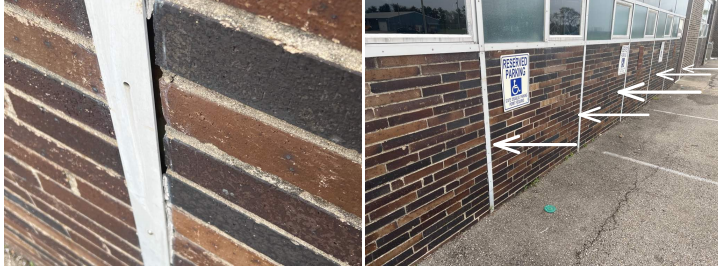
- ☐☐☐☒ Caulking: Sealant >>> Joints failing (Potential for water intrusion) Particularly bad along the side with rooms 113 and 112
Expansion joints in the brick on the wall of 113 failed

4. High Rise lower entrance area Exterior Caulking: Sealant >>> Joints failing (Potential for water intrusion) Particularly bad along the side with rooms 113 and 112

Expansion joints in the brick on the wall of 113 failed

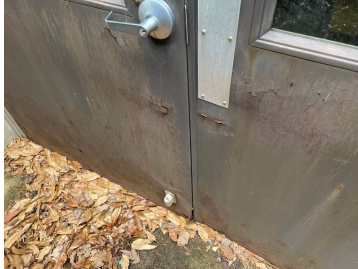
- ☐☐☐☒ Rear Door: Steel with Glass Insert >>> Doors in stairwell to boiler room rusted through failing

5. High Rise lower entrance area Exterior Rear Door: Steel with Glass Insert >>> Doors in stairwell to boiler room rusted through failing

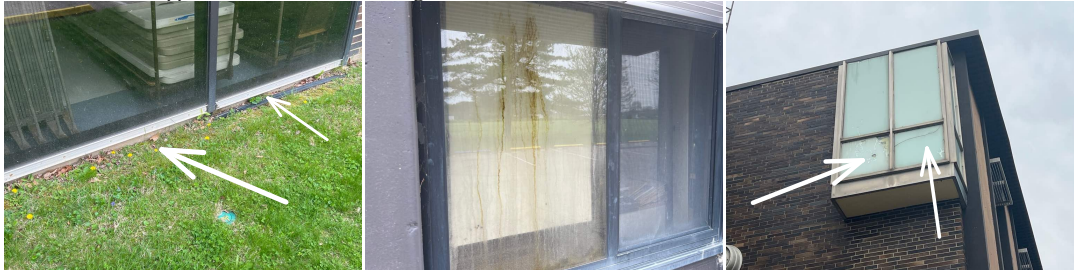
- ☐☐☒☐ Windows: Aluminum Construction >>> Trim strips missing on stairwell windows
A few window seals failing
Glass cracked on upper rear window in overhang

5. High Rise lower entrance area Exterior Windows: Aluminum Construction >>> Trim strips missing on stairwell windows
A few window seals failing
Glass cracked on upper rear window in overhang

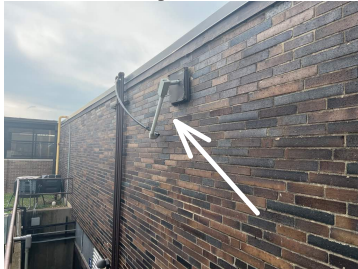
- ☐☐☒☐ Screens: (Mesh in Frame) >>> Screens should be removed from all windows that do not require
☐☐☒ Lighting: Surface Mount Fixture(s) >>> Lighting is dated giving poor illumination and not energy efficient
☐☒☐ Electrical: Components >>> Conduit unsecured temporary installation above the exterior stairwell

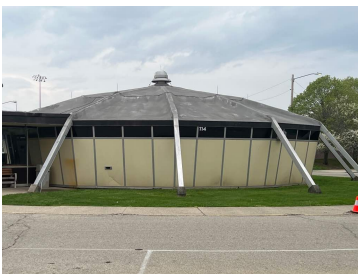
Music Room Exterior

- ☒ ☐ ☐ ☐ ☐ Fascia: Aluminum
☒ ☐ ☐ ☐ ☐ Soffits: Aluminum
☐ ☐ ☐ ☒ ☐ Surface: Transite Panels (possible asbestos content) >>> Four large panels damaged needing replacement
 Makeshift installation of window air conditioners: heating and cooling of this building may need to be evaluated

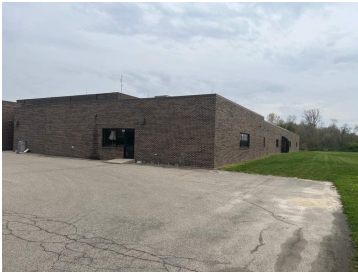
Rear Building Exterior

- ☐ ☐ ☒ ☐ ☐ Surface: Brick(FAQ-Exterior) >>> Roof scuppers emptying water down the wall which will cause problems with the brick

☐☐☐☒ Soffits: Plywood >>> Not protected from moisture

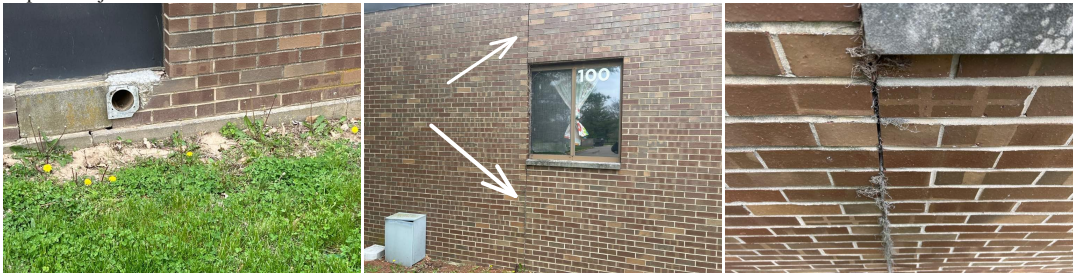
☐☐☐☒ Surface: Brick(FAQ-Exterior) >>> Vent missing louver or cover (allowing air infiltration, potential for animals to enter)
 Poor location easy for animals to enter
 Windowsill cracked potential for water intrusion: #100
 Expansion joint not caulked

8. Shoe Boxes Exterior Surface: Brick(FAQ-Exterior) >>> Vent missing louver or cover (allowing air infiltration, potential for animals to enter)
Poor location easy for animals to enter
Windowsill cracked potential for water intrusion: #100
Expansion joint not caulked

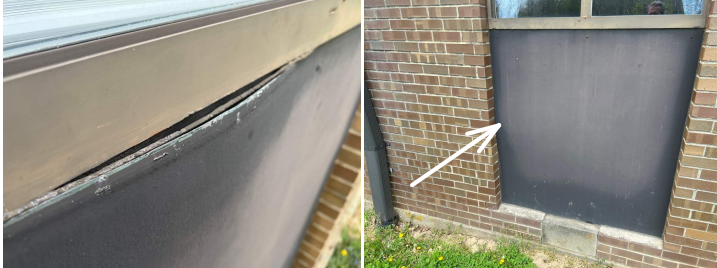
☐☐☐☒ Surface: Metal Sheetting >>> Loose panels with water getting behind: Potential from moisture damage to substrate

7. Shoe Boxes Exterior Surface: Metal Sheeting >>> Loose panels with water getting behind: Potential from moisture damage to substrate

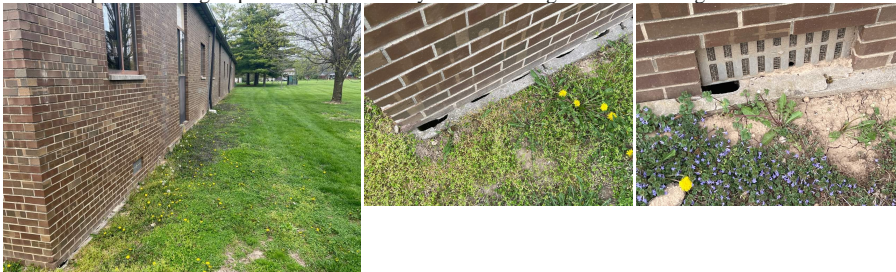
☐☐☐☒ Foundation: Concrete Block Construction >>> Not matched up with the brick walls allowing for water to runoff the brick into the cavity and possibly into the crawlspace: flashing required: Approximately 3/4 of the length of the building

8. Shoe Boxes Exterior Foundation: Concrete Block Construction >>> Not matched up with the brick walls allowing for water to runoff the brick into the cavity and possibly into the crawlspace: flashing required: Approximately 3/4 of the length of the building

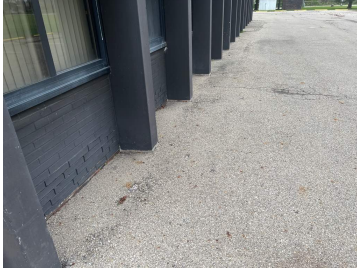
☐☐☒☐ Car Parking: Blacktop Surface(FAQ-Sealants) >>> Areas along the base of building have a negative slope holding water directing it into the foundation

10. Surrounding Building Grounds Commercial Car Parking: Blacktop Surface(FAQ-Sealants) >>> Areas along the base of building have a negative slope holding water directing it into the foundation

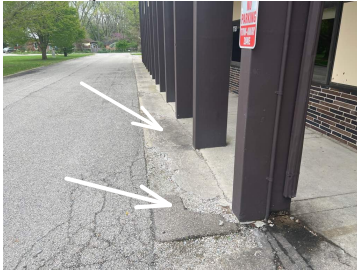
☐☐☒☐ Walkways: Concrete(FAQ-Sealants) >>> Deteriorated surface between pillars and blacktop

11. Surrounding Building Grounds Commercial Walkways: Concrete(FAQ-Sealants) >>> Deteriorated surface between pillars and blacktop

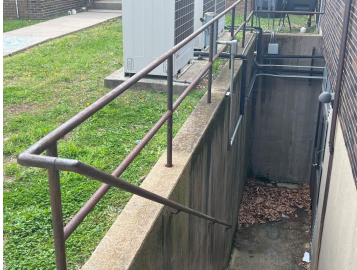
☐☐☐☒ Stairwell: Concrete Construction >>> Railing type does not meet today's standard for safety

9. Surrounding Building Grounds Commercial Stairwell: Concrete Construction >>> Railing type does not meet today's standard for safety

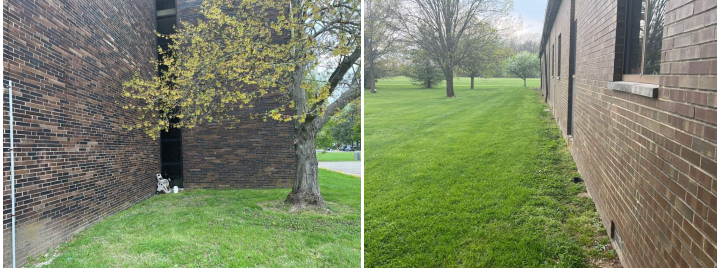
☐☐☐☒ Grading: Areas Need Attention >>> Grading has negative slope with potential for water pooling along foundation at the high rise stairwell (potential for damp problems in structure and premature foundation failure, any grading improvement to channel water away from the structure would be beneficial to foundation)

Ground along rear shoebox foundation is lower than general grade and holding water (potential for damp problems in structure and premature foundation failure, any grading improvement to stop water pooling would be beneficial to foundation)

10. Surrounding Building Grounds Commercial Grading: Areas Need Attention >>> Grading has negative slope with potential for water pooling along foundation at the high rise stairwell (potential for damp problems in structure and premature foundation failure, any grading improvement to channel water away from the structure would be beneficial to foundation)

Ground along rear shoebox foundation is lower than general grade and holding water (potential for damp problems in structure and premature foundation failure, any grading improvement to stop water pooling would be beneficial to foundation)

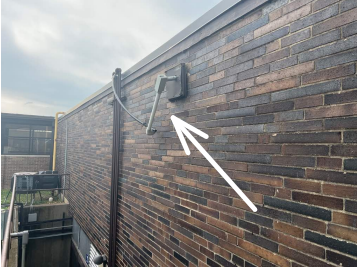
1. High Rise lower entrance area Exterior Screens: (Mesh in Frame) >>> Screens should be removed from all windows that do not require
2. High Rise lower entrance area Exterior Electrical: Components >>> Conduit unsecured temporary installation above the exterior stairwell

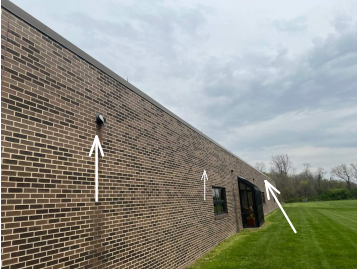
3. Rear Building Exterior Surface: Brick(FAQ-Exterior) >>> Roof scuppers emptying water down the wall which will cause problems with the brick

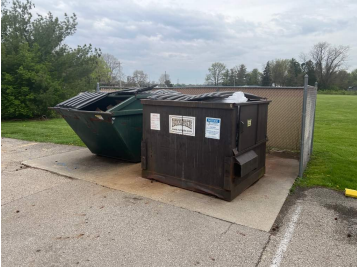
6. Surrounding Building Grounds Commercial Garbage Area: Fenced >>> Unsightly/ dumpsters not as far into enclosure as possible

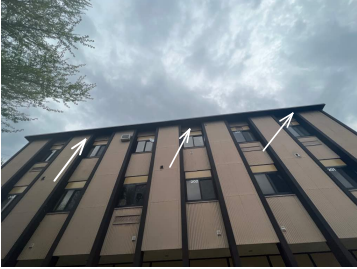
1. High Rise lower entrance area Exterior Fascia: Aluminum >>> Fascia damaged in the food delivery
2. High Rise lower entrance area Exterior Soffits: Aluminum >>> Not sealed with birds entering through the unsealed undulations in the roof decking

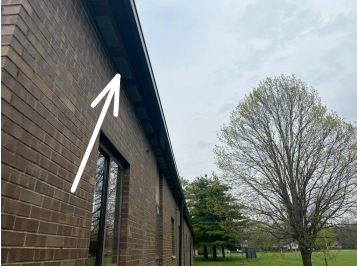
7. Shoe Boxes Exterior Soffits: Plywood >>> Not protected from moisture

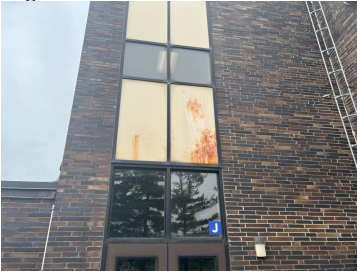
1. High Rise lower entrance area Exterior Surface: Aluminum Panels(FAQ-Exterior) >>> Two panels above Jorge are rusted through requiring replacement

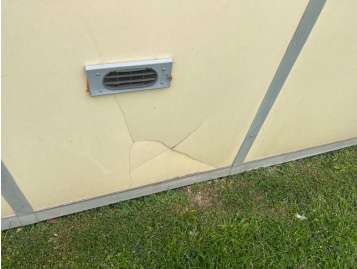
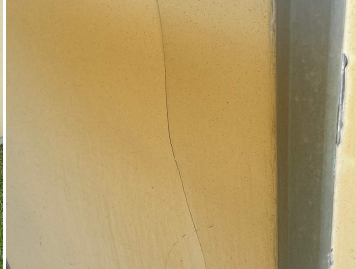
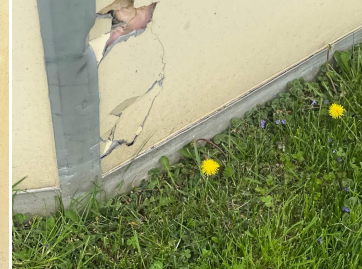
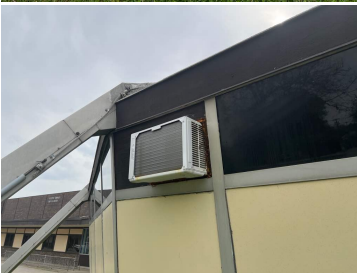
6. Music Room Exterior Surface: Transite Panels (possible asbestos content) >>> Four large panels damaged needing replacement
Makeshift installation of window air conditioners: heating and cooling of this building may need to be evaluated
